Access Compliance Report

Public Rights-of-Way

(Curb Ramps)

Intersection ID: 12701	Main Street: HICKORY GROVE RD	Cross Street: MARKET ST	Location: NW
ADA ID: C08BF182901B	Ramp Type: PerpDiag	Initial Pass/Fail: Fail	Overall Compliance: No
		Severity Score: 35

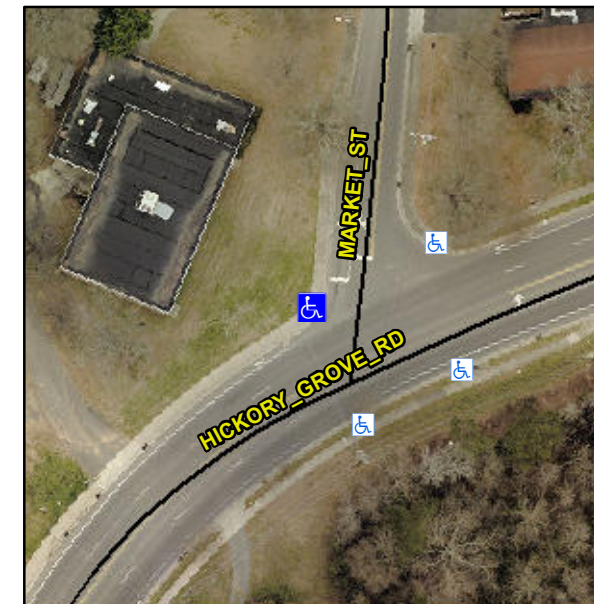
Not Found, R304.5.1, R304.2.2, R304.5.3

Compliance	Description	Data	Compliance	Description	Data
N/A	Ramp Length (in)	25.0	No	Ramp Slope (%)	14.8
No	Ramp Width (in)	41.0	No	Ramp XSlope (%)	2.3
N/A	Flare Type LT	N/A	N/A	Flare Type RT	N/A
N/A	Flare Slope LT (%)	N/A	N/A	Flare Slope RT (%)	N/A
N/A	Flare Traversable LT?	N/A	N/A	Flare Traversable RT?	N/A
N/A	Landing Length (in)	N/A	N/A	DWS Provided?	N/A
N/A	Landing Width (in)	N/A	N/A	DWS Contrast?	N/A
N/A	Landing Slope (%)	N/A	N/A	DWS Length (in)	N/A
N/A	Landing X Slope (%)	N/A	N/A	DWS Full Width?	N/A
N/A	Landing Curb? (Y/N)	N/A	N/A	DWS Offset (in)	N/A
N/A	Shared Landing?	N/A			
N/A	Gutter Ponding?	N/A	N/A	Gutter Slope (%)	N/A
N/A	Gutter Lip Ht (in)	N/A	N/A	Gutter X Slope (%)	N/A
N/A	Painted X Walk1?	No	N/A	Painted X Walk2?	No
	X Walk 1 Direction	To S		X Walk 2 Direction	To NE
N/A	X Walk 1 Width (in)	N/A	N/A	X Walk 2 Width (in)	N/A
	X Walk 1 Slope (%)	0.4		X Walk 2 Slope (%)	0.7
	X Walk 1 X Slope (%)	1.0		X Walk 2 X Slope (%)	2.0

N/A	Ramp inside XWalk1?	N/A	N/A	Ramp inside XWalk2?	N/A
	Road Slope (%)	0.6	N/A	Clear Space?	N/A
	Road X Slope (%)	0.4	N/A	Clear Space to XWalk (in)	N/A
N/A	Any Obstructions?	N/A	N/A	Storm Grate/Utility Hazard?	N/A
	Obstruction Type			Storm Grate/Utility Type	
		N/A			N/A
			Yes	Surface Condition? (G/P)	Good

Remove & Replace Curb Ramp With Two New Directional Ramps or Equivalent.
