Access Compliance Report Public Rights-of-Way (Curb Ramps)

Intersection ID: 4291 Main Street: BROOKSTONE_DR Cross Street: W_W_T_HARRIS_BV Location: S

ADA ID: C0919FB44242 Ramp Type: BlendTrans1 Initial Pass/Fail: Fail Overall Compliance: No Severity Score: 25

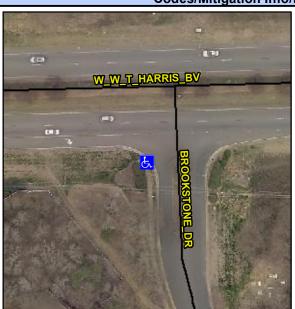
NO RT SW

R304.5.3

Field Measurements/Component Compliance						
	Compliance Description		Data	Comp	liance Description	Data
	N/A	Ramp Length (in)	52.0	Yes	BlendTrans Slope (%)	3.2
	Yes	Ramp Width (in)	48.0	No	BlendTrans XSlope (%)	7.6
	N/A	Flare Type LT	N/A	N/A	Flare Type RT	N/A
	N/A	Flare Slope LT (%)	N/A	N/A	Flare Slope RT (%)	N/A
	N/A	Flare Traversable LT?	N/A	N/A	Flare Traversable RT?	N/A
	N/A	Landing Length (in)	N/A	N/A	DWS Provided?	N/A
	N/A	Landing Width (in)	N/A	N/A	DWS Contrast?	N/A
	N/A	Landing Slope (%)	N/A	N/A	DWS Length (in)	N/A
	N/A	Landing X Slope (%)	N/A	N/A	DWS Full Width?	N/A
	N/A	Landing Curb? (Y/N)	N/A	N/A	DWS Offset (in)	N/A
	N/A	Shared Landing?	N/A			
	N/A	Gutter Ponding?	N/A	N/A	Gutter Slope (%)	N/A
	N/A	Gutter Lip Ht (in)	2.0	N/A	Gutter X Slope (%)	N/A
	N/A	Painted X Walk1?	No	N/A	Painted X Walk2?	N/A
		X Walk 1 Direction	To E		X Walk 2 Direction	N/A
		X Walk 1 Width (in)	N/A		X Walk 2 Width (in)	N/A

X Walk 1 Slope (%)	3.4		X Walk 2 Slope (%)	N/A
		X Walk 1 X Slope (%)	6.5		X Walk 2 X Slope (%)	N/A
	N/A	Ramp inside XWalk1?	N/A	N/A	Ramp inside XWalk2?	N/A
		Road Slope (%)	6.5		Clear Space?	N/A
		Road X Slope (%)	3.4	N/A	Clear Space to XWalk (in)	N/A
	N/A	Any Obstructions?	N/A	N/A	Storm Grate/Utility Hazard?	N/A
		Obstruction Type			Storm Grate/Utility Type	
			N/A			N/A
				Yes	Surface Condition? (G/P)	Good
		Salar		N/A	Curb Slope (%)	N/A

Remove & Replace Curb Ramp With
Two New Directional Ramps or
Equivalent.
