# Access Compliance Report

## Public Rights-of-Way

### (Curb Ramps)

| Intersection ID: 30545 | Main Street: COLONY_RD | Cross Street: STONECROFT_PARK_DR | Location: SW |

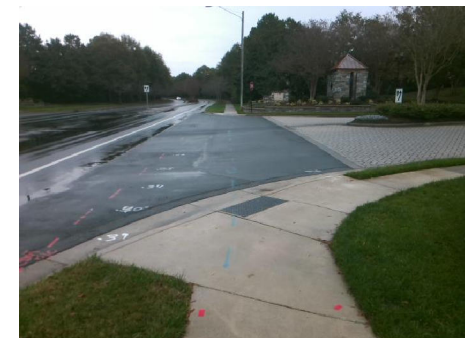
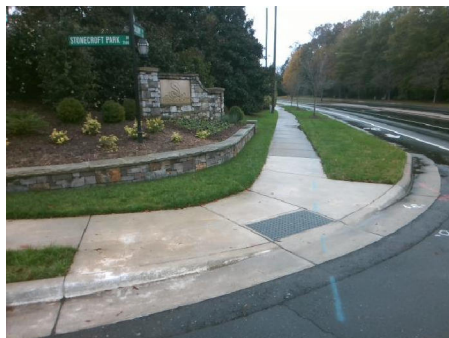
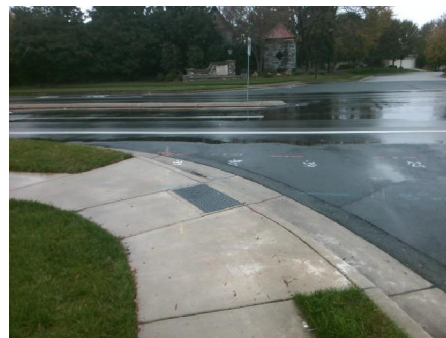
| ADA ID: C091FD84724B | Ramp Type: BlendTrans1 | Initial Pass/Fail: Pass | Overall Compliance: No |
| | | Severity Score: 2.5 | |

**Not Found, R304.2.1, R305.1.4**

| Compliance | Description | Data | Compliance | Description | Data |
|---|---|---|---|---|---|
| No | Landing Length (in) | 44.0 | Yes | DWS Provided? | Yes |
| Yes | Landing X Slope (%) | 1.7 | No | DWS Full Width? | No |
| | | | No | Curb Slope (%) | 6.8 |

**Remove & Replace Curb Ramp With Two New Directional Ramps or Equivalent.**

Total Cost: \$ 3200.00
