Access Compliance Report

Public Rights-of-Way

(Curb Ramps)

Intersection ID: 43412	Main Street: PROVIDENCE_CHURCH_LN	Cross Street: PROVIDENCE_RD	Location: NE
ADA ID: C0993B5EC0D2	Ramp Type: Perp	Initial Pass/Fail: Fail	Overall Compliance: No
Severity Score: 22.5			
Codes/Mitigation Info/Possible Solution		Field Measurements/Component Compliance

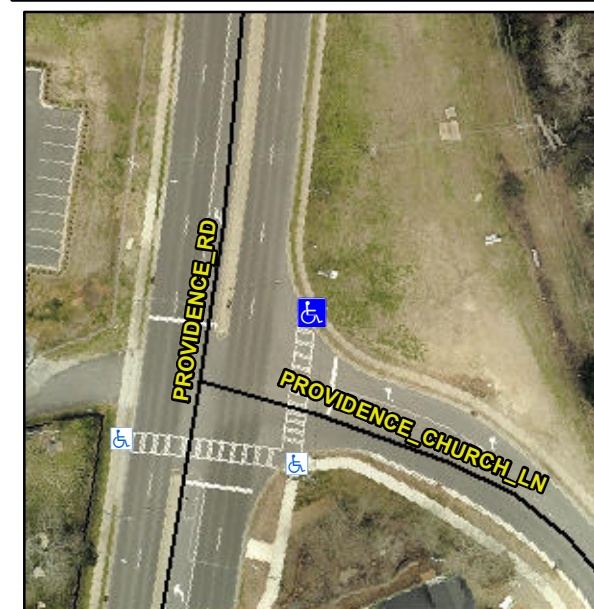
Not Found, R304.5.1, R304.2.2, R304.5.3

Compliance	Description	Data	Compliance	Description	Data
N/A	Ramp Length (in)	85.0	No	Ramp Slope (%)	9.0
No	Ramp Width (in)	44.5	No	Ramp XSlope (%)	4.1
N/A	Flare Type LT	N/A	N/A	Flare Type RT	N/A
N/A	Flare Slope LT (%)	N/A	N/A	Flare Slope RT (%)	N/A
N/A	Flare Traversable LT?	N/A	N/A	Flare Traversable RT?	N/A
N/A	Landing Length (in)	N/A	N/A	DWS Provided?	N/A
N/A	Landing Width (in)	N/A	N/A	DWS Contrast?	N/A
N/A	Landing Slope (%)	N/A	N/A	DWS Length (in)	N/A
N/A	Landing X Slope (%)	N/A	N/A	DWS Full Width?	N/A
N/A	Landing Curb? (Y/N)	N/A	N/A	DWS Offset (in)	N/A
N/A	Shared Landing?	N/A			
N/A	Gutter Ponding?	N/A	N/A	Gutter Slope (%)	N/A
N/A	Gutter Lip Ht (in)	N/A	N/A	Gutter X Slope (%)	N/A
N/A	Painted X Walk1?	Yes	N/A	Painted X Walk2?	N/A
	X Walk 1 Direction	To S		X Walk 2 Direction	N/A
N/A	X Walk 1 Width (in)	97.0	N/A	X Walk 2 Width (in)	N/A
	X Walk 1 Slope (%)	5.1		X Walk 2 Slope (%)	N/A
	X Walk 1 X Slope (%)	1.9		X Walk 2 X Slope (%)	N/A

N/A	Ramp inside XWalk1?	Yes	N/A	Ramp inside XWalk2?	N/A
	Road Slope (%)	N/A	N/A	Clear Space?	N/A
	Road X Slope (%)	N/A	N/A	Clear Space to XWalk (in)	N/A
N/A	Any Obstructions?	N/A	N/A	Storm Grate/Utility Hazard?	N/A
	Obstruction Type			Storm Grate/Utility Type	
		N/A			N/A
			Yes	Surface Condition? (G/P)	Good

Possible Solutions:

Remove & Replace Entire Ramp.
