Access Compliance Report

Public Rights-of-Way

(Curb Ramps)

Intersection ID: 54318	Main Street: CANTERBURY_CASTLE_DR	Cross Street: BELMONT_MANSION_DR	Location: SE
ADA ID: C0A7D101C743	Ramp Type: Perp	Initial Pass/Fail: Fail	Overall Compliance: No
Codes/Mitigation Info/Possible Solution			Severity Score: 21.25
			Field Measurements/Component Compliance

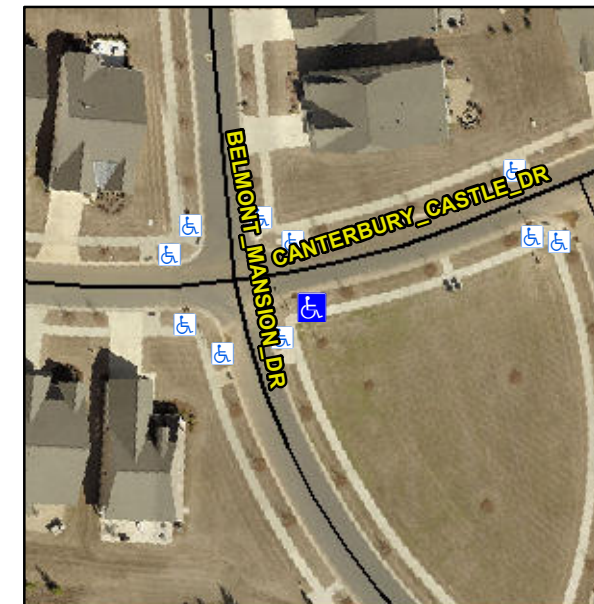
Compliance	Description	Data	Compliance	Description	Data
N/A	Ramp Length (in)	88.0	No	Ramp Slope (%)	9.7
No	Ramp Width (in)	46.5	Yes	Ramp XSlope (%)	0.5
N/A	Flare Type LT	N/A	N/A	Flare Type RT	N/A
N/A	Flare Slope LT (%)	N/A	N/A	Flare Slope RT (%)	N/A
N/A	Flare Traversable LT?	N/A	N/A	Flare Traversable RT?	N/A
N/A	Landing Length (in)	N/A	N/A	DWS Provided?	N/A
N/A	Landing Width (in)	N/A	N/A	DWS Contrast?	N/A
N/A	Landing Slope (%)	N/A	N/A	DWS Length (in)	N/A
N/A	Landing X Slope (%)	N/A	N/A	DWS Full Width?	N/A
N/A	Landing Curb? (Y/N)	N/A	N/A	DWS Offset (in)	N/A
N/A	Shared Landing?	N/A			
N/A	Gutter Ponding?	N/A	N/A	Gutter Slope (%)	N/A
N/A	Gutter Lip Ht (in)	1.0	N/A	Gutter X Slope (%)	N/A
N/A	Painted X Walk1?	No	N/A	Painted X Walk2?	N/A
	X Walk 1 Direction	To N		X Walk 2 Direction	N/A
N/A	X Walk 1 Width (in)	N/A	N/A	X Walk 2 Width (in)	N/A
	X Walk 1 Slope (%)	3.4		X Walk 2 Slope (%)	N/A
	X Walk 1 X Slope (%)	0.4		X Walk 2 X Slope (%)	N/A

Possible Solutions:

Remove & Replace Entire Ramp.

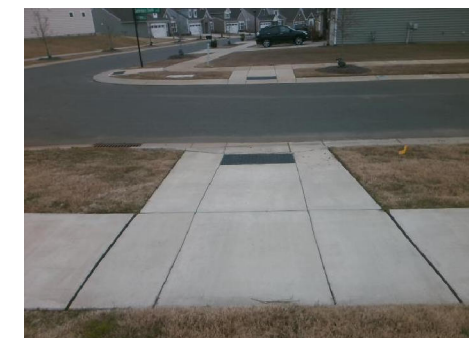
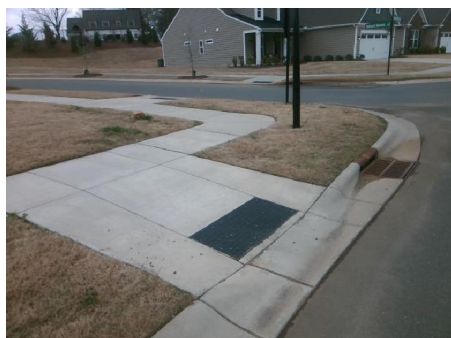
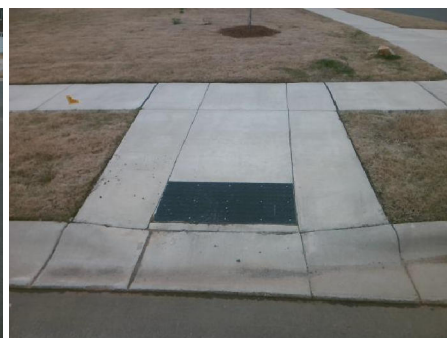
N/A	Ramp inside XWalk1?	N/A	N/A	Ramp inside XWalk2?	N/A
	Road Slope (%)	N/A	N/A	Clear Space?	N/A
	Road X Slope (%)	N/A	N/A	Clear Space to XWalk (in)	N/A
N/A	Any Obstructions?	N/A	N/A	Storm Grate/Utility Hazard?	N/A
	Obstruction Type			Storm Grate/Utility Type	
		N/A			N/A
			Yes	Surface Condition? (G/P)	Good
