Access Compliance Report

Public Rights-of-Way

(Curb Ramps)

Intersection ID: 49140	Main Street: POPE_FARM_RD	Cross Street: CEMKEY_WAY_CT	Location: SE
ADA ID: C0B706BB72B2	Ramp Type: Perp	Initial Pass/Fail: Fail	Overall Compliance: No
Severity Score: 8.75			
Codes/Mitigation Info/Possible Solution		Field Measurements/Component Compliance

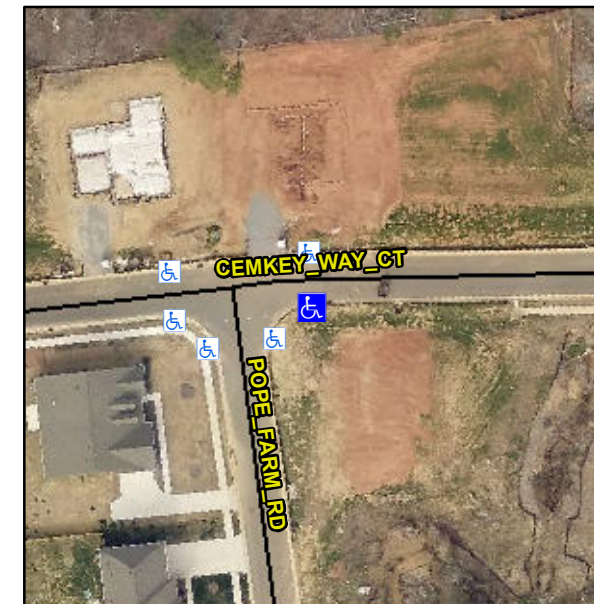
Not Found, R304.5.1

Compliance	Description	Data	Compliance	Description	Data
N/A	Ramp Length (in)	52.0	Yes	Ramp Slope (%)	7.2
No	Ramp Width (in)	47.0	Yes	Ramp XSlope (%)	0.5
N/A	Flare Type LT	N/A	N/A	Flare Type RT	N/A
N/A	Flare Slope LT (%)	N/A	N/A	Flare Slope RT (%)	N/A
N/A	Flare Traversable LT?	N/A	N/A	Flare Traversable RT?	N/A
N/A	Landing Length (in)	N/A	N/A	DWS Provided?	N/A
N/A	Landing Width (in)	N/A	N/A	DWS Contrast?	N/A
N/A	Landing Slope (%)	N/A	N/A	DWS Length (in)	N/A
N/A	Landing X Slope (%)	N/A	N/A	DWS Full Width?	N/A
N/A	Landing Curb? (Y/N)	N/A	N/A	DWS Offset (in)	N/A
N/A	Shared Landing?	N/A			
N/A	Gutter Ponding?	Yes	N/A	Gutter Slope (%)	N/A
N/A	Gutter Lip Ht (in)	N/A	N/A	Gutter X Slope (%)	N/A
N/A	Painted X Walk1?	No	N/A	Painted X Walk2?	N/A
	X Walk 1 Direction	To N		X Walk 2 Direction	N/A
N/A	X Walk 1 Width (in)	N/A	N/A	X Walk 2 Width (in)	N/A
	X Walk 1 Slope (%)	4.2		X Walk 2 Slope (%)	N/A
	X Walk 1 X Slope (%)	0.7		X Walk 2 X Slope (%)	N/A

N/A	Ramp inside XWalk1?	N/A	N/A	Ramp inside XWalk2?	N/A
	Road Slope (%)	N/A	N/A	Clear Space?	N/A
	Road X Slope (%)	N/A	N/A	Clear Space to XWalk (in)	N/A
N/A	Any Obstructions?	N/A	N/A	Storm Grate/Utility Hazard?	N/A
	Obstruction Type			Storm Grate/Utility Type	
		N/A			N/A
		Yes		Surface Condition? (G/P)	Good

Remove & Replace Entire Ramp.
