# Access Compliance Report

## Public Rights-of-Way

### (Curb Ramps)

Intersection ID: N/A	Main Street: SHARON RD	Cross Street: HAZELTON DR	Location: NW
ADA ID: C0B9DB1911D7	Ramp Type: Perp	Initial Pass/Fail: Fail	Overall Compliance: No
Severity Score: 13.75			
Codes/Mitigation Info/Possible Solution		Field Measurements/Component Compliance

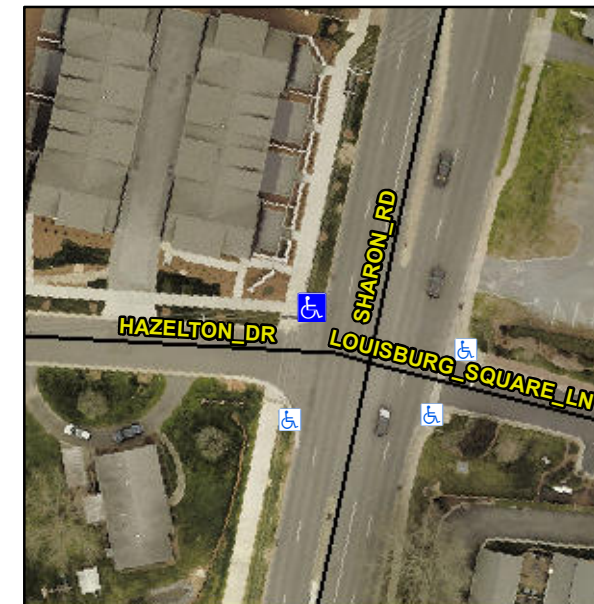
PROW/ADA:

**R304.2.2, R304.5.3**

Compliance	Description	Data	Compliance	Description	Data
N/A	Ramp Length (in)	40.0	No	Ramp Slope (%)	11.9
Yes	Ramp Width (in)	120.0	No	Ramp XSlope (%)	3.2
N/A	Flare Type LT	N/A	N/A	Flare Type RT	N/A
N/A	Flare Slope LT (%)	N/A	N/A	Flare Slope RT (%)	N/A
N/A	Flare Traversable LT?	No	N/A	Flare Traversable RT?	No
N/A	Landing Length (in)	N/A	N/A	DWS Provided?	N/A
N/A	Landing Width (in)	N/A	N/A	DWS Contrast?	N/A
N/A	Landing Slope (%)	N/A	N/A	DWS Length (in)	N/A
N/A	Landing X Slope (%)	N/A	N/A	DWS Full Width?	N/A
N/A	Landing Curb? (Y/N)	N/A	N/A	DWS Offset (in)	N/A
N/A	Shared Landing?	N/A			
N/A	Gutter Ponding?	N/A	N/A	Gutter Slope (%)	N/A
N/A	Gutter Lip Ht (in)	N/A	N/A	Gutter X Slope (%)	N/A
N/A	Painted X Walk1?	No	N/A	Painted X Walk2?	N/A
	X Walk 1 Direction	To S		X Walk 2 Direction	N/A
N/A	X Walk 1 Width (in)	N/A	N/A	X Walk 2 Width (in)	N/A
	X Walk 1 Slope (%)	3.1		X Walk 2 Slope (%)	N/A
	X Walk 1 X Slope (%)	4.1		X Walk 2 X Slope (%)	N/A

N/A	Ramp inside XWalk1?	N/A	N/A	Ramp inside XWalk2?	N/A
	Road Slope (%)	N/A	N/A	Clear Space?	N/A
	Road X Slope (%)	N/A	N/A	Clear Space to XWalk (in)	N/A
N/A	Any Obstructions?	N/A	N/A	Storm Grate/Utility Hazard?	N/A
	Obstruction Type			Storm Grate/Utility Type	
		N/A			N/A
		Yes		Surface Condition? (G/P)	Good

Possible Solutions:

**Remove & Replace Entire Ramp.**
