# Access Compliance Report

## Public Rights-of-Way

### (Curb Ramps)

Intersection ID: 42943	Main Street: LONG_PAW_LN	Cross Street: SONOMA_VALLEY_DR	Location: S
ADA ID: C0BE6006A298	Ramp Type: PerpDiag	Initial Pass/Fail: Fail	Overall Compliance: No
Severity Score: 8.75			
Codes/Mitigation Info/Possible Solution		Field Measurements/Component Compliance

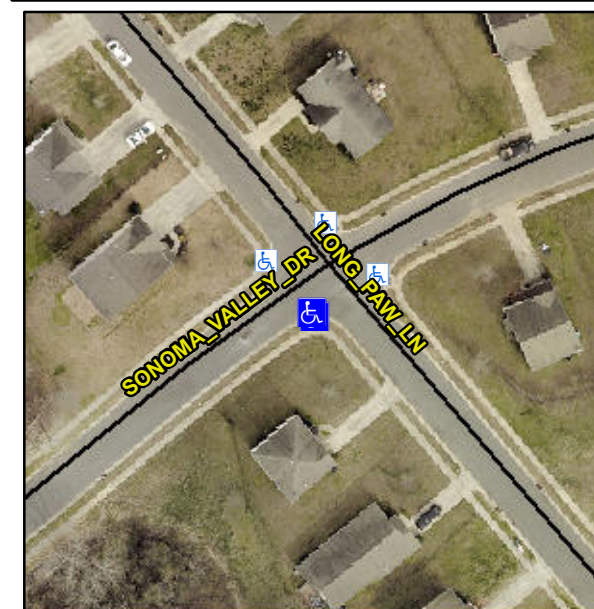
**Not Found, R304.5.1**

Compliance	Description	Data	Compliance	Description	Data
N/A	Ramp Length (in)	48.0	Yes	Ramp Slope (%)	7.6
No	Ramp Width (in)	40.0	Yes	Ramp XSlope (%)	1.0
N/A	Flare Type LT	N/A	N/A	Flare Type RT	N/A
N/A	Flare Slope LT (%)	N/A	N/A	Flare Slope RT (%)	N/A
N/A	Flare Traversable LT?	N/A	N/A	Flare Traversable RT?	N/A
N/A	Landing Length (in)	N/A	N/A	DWS Provided?	N/A
N/A	Landing Width (in)	N/A	N/A	DWS Contrast?	N/A
N/A	Landing Slope (%)	N/A	N/A	DWS Length (in)	N/A
N/A	Landing X Slope (%)	N/A	N/A	DWS Full Width?	N/A
N/A	Landing Curb? (Y/N)	N/A	N/A	DWS Offset (in)	N/A
N/A	Shared Landing?	N/A			
N/A	Gutter Ponding?	N/A	N/A	Gutter Slope (%)	N/A
N/A	Gutter Lip Ht (in)	N/A	N/A	Gutter X Slope (%)	N/A
N/A	Painted X Walk1?	No	N/A	Painted X Walk2?	No
	X Walk 1 Direction	To NE		X Walk 2 Direction	To NW
N/A	X Walk 1 Width (in)	N/A	N/A	X Walk 2 Width (in)	N/A
	X Walk 1 Slope (%)	0.9		X Walk 2 Slope (%)	1.3
	X Walk 1 X Slope (%)	0.7		X Walk 2 X Slope (%)	0.0

N/A	Ramp inside XWalk1?	N/A	N/A	Ramp inside XWalk2?	N/A
	Road Slope (%)	0.6	N/A	Clear Space?	N/A
	Road X Slope (%)	1.4	N/A	Clear Space to XWalk (in)	N/A
N/A	Any Obstructions?	N/A	N/A	Storm Grate/Utility Hazard?	N/A
	Obstruction Type			Storm Grate/Utility Type	
		N/A			N/A
			Yes	Surface Condition? (G/P)	Good

**Remove & Replace Curb Ramp With Two New Directional Ramps or Equivalent.**

Total Cost: \$ 3200.00
