Access Compliance Report

Public Rights-of-Way

(Curb Ramps)

Intersection ID: 21296	Main Street: E_ARROWOOD_RD	Cross Street: ENGLAND_ST	Location: SE
ADA ID: C0C154CA2979	Ramp Type: Directional1	Initial Pass/Fail: Fail	Overall Compliance: No
		Severity Score: 13.75

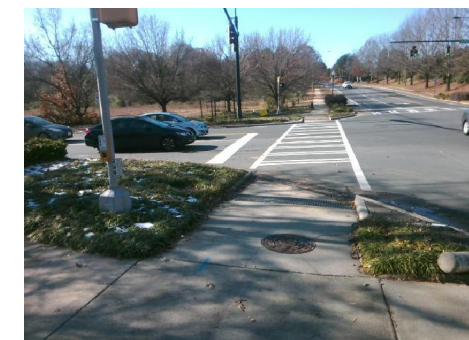
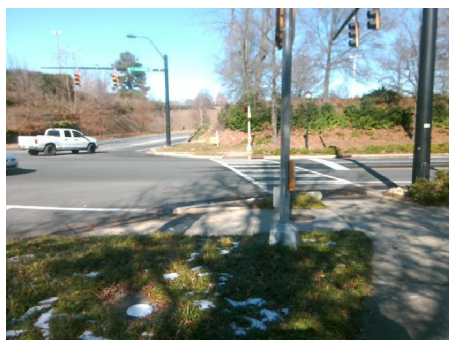
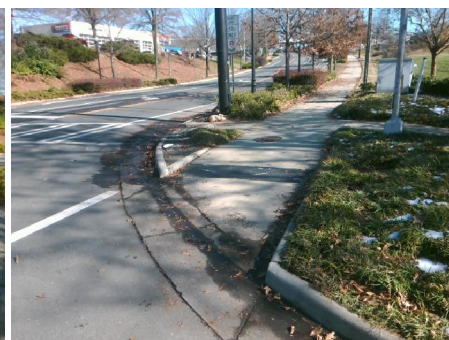
Compliance	Description	Data	Compliance	Description	Data
N/A	Ramp Length (in)	72.0	N/A	Grade Break?	N/A
Yes	Ramp Width (in)	97.0	N/A	Grade Break Slope (%)	0.0
No	Ramp Slope (%)	11.3	N/A	Grade Break XSlope (%)	0.0
No	Ramp XSlope (%)	2.4			
N/A	Flare Type LT	N/A	N/A	Flare Type RT	N/A
N/A	Flare Slope LT (%)	N/A	N/A	Flare Slope RT (%)	0.0
N/A	Flare Traversable LT?	N/A	N/A	Flare Traversable RT?	N/A
N/A	Landing Length (in)	0.0	N/A	DWS Provided?	N/A
N/A	Landing Width (in)	0.0	N/A	DWS Contrast?	N/A
N/A	Landing Slope (%)	0.0	N/A	DWS Length (in)	N/A
N/A	Landing X Slope (%)	0.0	N/A	DWS Full Width?	N/A
N/A	Landing Curb? (Y/N)	N/A	N/A	DWS Offset LT (in)	N/A
N/A	Shared Landing?	N/A	N/A	DWS Offset RT (in)	N/A
N/A	Gutter Ponding?	0.0	N/A	Gutter Slope (%)	N/A
N/A	Gutter Lip Ht (in)	0.0	N/A	Gutter X Slope (%)	N/A
N/A	Painted X Walk1?	Yes		Road Slope (%)	1.1
	X Walk 1 Direction	To W		Road X Slope (%)	2.0
	X Walk 1 Width (in)	109.0		Clear Space?	N/A

X Walk 1 Slope (%)	1.1	N/A	Clear Space to XWalk (in)	N/A
	X Walk 1 X Slope (%)	2.0	N/A	Storm Grate/Utility Hazard?	N/A
N/A	Ramp inside XWalk1?	Yes		Storm Grate/Utility Type	
N/A	Any Obstructions?	N/A			N/A
	Obstruction Type		Yes	Surface Condition? (G/P)	Good
			N/A	Curb Slope (%)	2.3

Remove & Replace Entire Ramp.
