Access Compliance Report

Public Rights-of-Way

(Curb Ramps)

Intersection ID: 45220	Main Street: ARDREY_KELL_RD	Cross Street: HARCOMBE_DR	Location: SE
ADA ID: C0C7E36A5B76	Ramp Type: Perp	Initial Pass/Fail: Fail	Overall Compliance: No
			Severity Score: 21.25

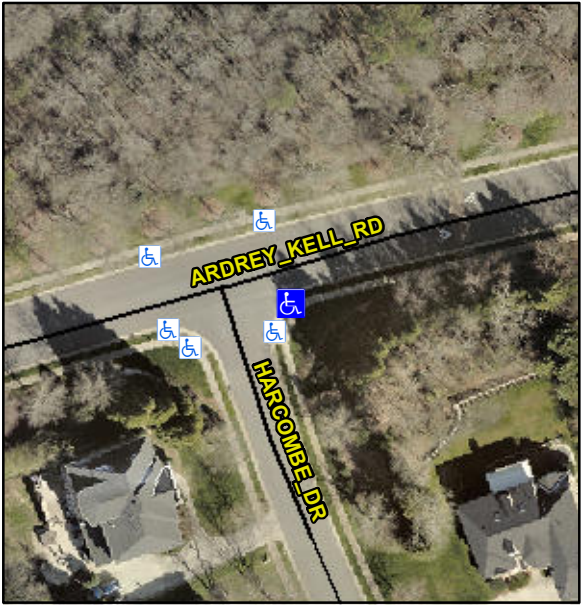
Possible Solutions:		Compliance	Description	Data
	Remove & Replace Entire Ramp.		No	Ramp Length (in)	47.0
			No	Ramp Width (in)	41.0
			N/A	Flare Type LT	N/A
			N/A	Flare Slope LT (%)	N/A
			N/A	Flare Traversable LT?	N/A
			N/A	Landing Length (in)	N/A
			N/A	Landing Width (in)	N/A
			N/A	Landing Slope (%)	N/A
			N/A	Landing X Slope (%)	N/A
<p>Surveyor Notes:</p> <p>N/A</p> <p>PROW/ADA:</p> <p>Not Found, R304.5.1, R304.2.2</p>			N/A	Flare Type RT	N/A
			N/A	Flare Slope RT (%)	N/A
			N/A	Flare Traversable RT?	N/A
			N/A	DWS Provided?	N/A
			N/A	DWS Contrast?	N/A
			N/A	DWS Length (in)	N/A
			N/A	DWS Full Width?	N/A
			N/A	DWS Offset (in)	N/A
			N/A	Gutter Ponding?	N/A
			N/A	Gutter Lip Ht (in)	N/A
			No	Painted X Walk1?	N/A
			To N	X Walk 1 Direction	N/A
			N/A	X Walk 1 Width (in)	N/A

1.2	X Walk 1 Slope (%)	N/A
			1.0	X Walk 1 X Slope (%)	N/A
			N/A	Ramp inside XWalk1?	N/A
			N/A	Road Slope (%)	N/A
			N/A	Road X Slope (%)	N/A
			N/A	Any Obstructions?	N/A
				Obstruction Type	N/A
Total Cost:			\$	1850.00	
			N/A		N/A
			Yes	Surface Condition? (G/P)	Good
