# Access Compliance Report

## Public Rights-of-Way

### (Curb Ramps)

Intersection ID: 32311	Main Street: LAUREL_WALK_CT	Cross Street: NEW_PROVIDENCE_LN	Location: SE
ADA ID: C0C92803E8F4	Ramp Type: Perp	Initial Pass/Fail: Fail	Overall Compliance: No
Severity Score: 21.25			
Codes/Mitigation Info/Possible Solution		Field Measurements/Component Compliance

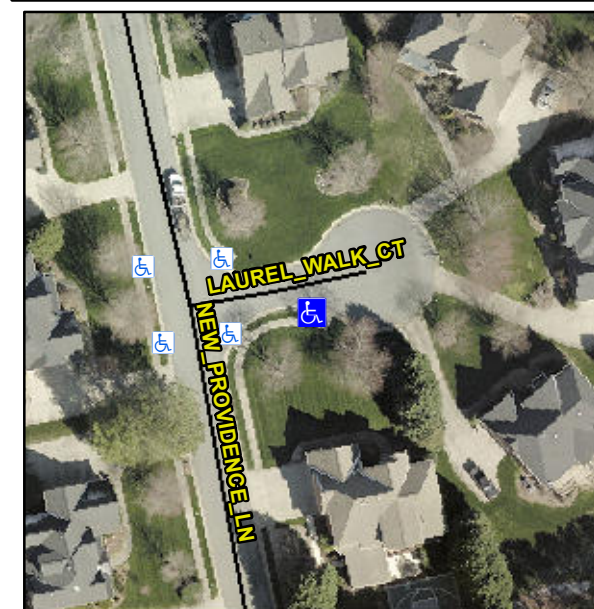
Compliance	Description	Data	Compliance	Description	Data
N/A	Ramp Length (in)	47.5	No	Ramp Slope (%)	8.6
No	Ramp Width (in)	42.0	Yes	Ramp XSlope (%)	1.2
N/A	Flare Type LT	N/A	N/A	Flare Type RT	N/A
N/A	Flare Slope LT (%)	N/A	N/A	Flare Slope RT (%)	N/A
N/A	Flare Traversable LT?	N/A	N/A	Flare Traversable RT?	N/A
N/A	Landing Length (in)	N/A	N/A	DWS Provided?	N/A
N/A	Landing Width (in)	N/A	N/A	DWS Contrast?	N/A
N/A	Landing Slope (%)	N/A	N/A	DWS Length (in)	N/A
N/A	Landing X Slope (%)	N/A	N/A	DWS Full Width?	N/A
N/A	Landing Curb? (Y/N)	N/A	N/A	DWS Offset (in)	N/A
N/A	Shared Landing?	N/A			
N/A	Gutter Ponding?	N/A	N/A	Gutter Slope (%)	N/A
N/A	Gutter Lip Ht (in)	N/A	N/A	Gutter X Slope (%)	N/A
N/A	Painted X Walk1?	No	N/A	Painted X Walk2?	N/A
	X Walk 1 Direction	To N		X Walk 2 Direction	N/A
N/A	X Walk 1 Width (in)	N/A	N/A	X Walk 2 Width (in)	N/A
	X Walk 1 Slope (%)	3.2		X Walk 2 Slope (%)	N/A
	X Walk 1 X Slope (%)	5.0		X Walk 2 X Slope (%)	N/A

N/A	Ramp inside XWalk1?	N/A	N/A	Ramp inside XWalk2?	N/A
	Road Slope (%)	N/A	N/A	Clear Space?	N/A
	Road X Slope (%)	N/A	N/A	Clear Space to XWalk (in)	N/A
N/A	Any Obstructions?	N/A	N/A	Storm Grate/Utility Hazard?	N/A
	Obstruction Type			Storm Grate/Utility Type	
		N/A			N/A
			Yes	Surface Condition? (G/P)	Good

Possible Solutions:

**Remove & Replace Entire Ramp.**
