# Access Compliance Report

## Public Rights-of-Way

### (Curb Ramps)

| Intersection ID: 44077 | Main Street: NEWLANDS_CORNER_LN | Cross Street: FOREST_RUN_LN | Location: NW |

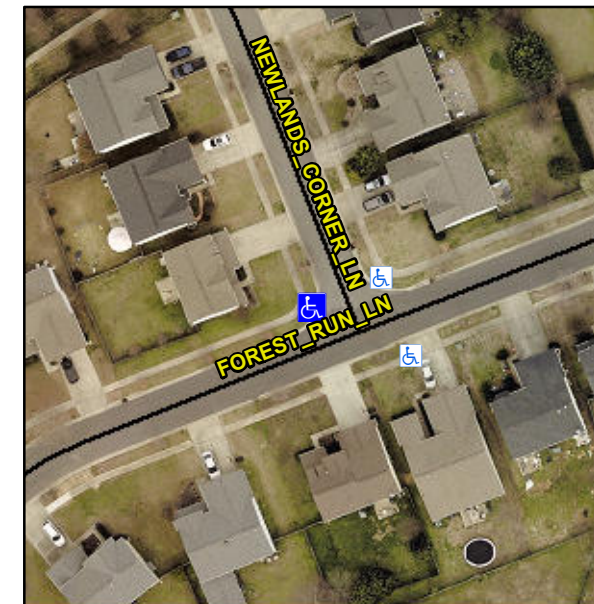
**GTR GAP 1.5**

**R304.5.1, R304.5.3**

| Compliance | Description | Data | Compliance | Description | Data |
|---|---|---|---|---|---|
| No | Ramp Width (in) | 25.0 | No | BlendTrans XSlope (%) | 3.6 |

**Remove & Replace Curb Ramp With Two New Directional Ramps or Equivalent.**
