# Access Compliance Report

## Public Rights-of-Way

### (Curb Ramps)

| Intersection ID: 14294 | Main Street: EAST_BV | Cross Street: EUCLID_AV | Location: NE |

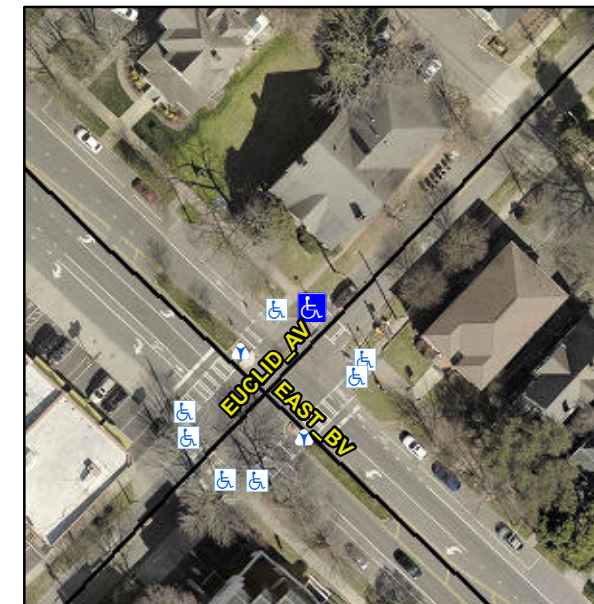
| Severity Score: 7.5 | | | |

**Not Found, R304.5.3, R302.7.2**

| Compliance | Description | Data | Compliance | Description | Data |
|---|---|---|---|---|---|
| Yes | Ramp Width (in) | 72.0 | No | Grade Break Slope (%) | 9.4 |
| Yes | Ramp Slope (%) | 2.8 | No | Grade Break XSlope (%) | 2.7 |
| No | Gutter Lip Ht (in) | 0.5 | Yes | Gutter X Slope (%) | 1.4 |

**Remove & Replace Entire Ramp.**

Total Cost: \$ 1600.00
