Access Compliance Report

Public Rights-of-Way

(Curb Ramps)

Intersection ID: 16228	Main Street: RADCLIFFE_AV	Cross Street: STANFORD_PL	Location: S
ADA ID: C0D683828CC9	Ramp Type: Directional1	Initial Pass/Fail: Fail	Overall Compliance: No
Codes/Mitigation Info/Possible Solution		Field Measurements/Component Compliance	
Severity Score: 13.75

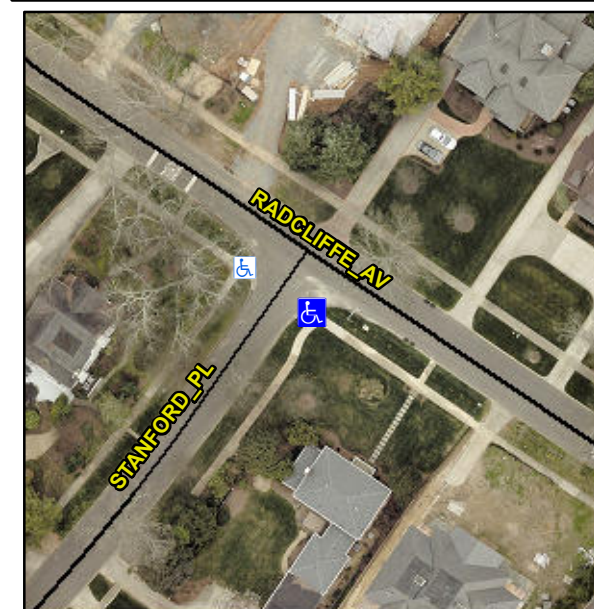
PONDING PREVENTED CURB SLOPE

PROW/ADA:

R304.2.2, R304.5.3

Compliance	Description	Data	Compliance	Description	Data
N/A	Ramp Length (in)	48.0	N/A	Grade Break?	N/A
Yes	Ramp Width (in)	62.0	N/A	Grade Break Slope (%)	0.0
No	Ramp Slope (%)	8.9	N/A	Grade Break XSlope (%)	0.0
No	Ramp XSlope (%)	4.0			
N/A	Flare Type LT	N/A	N/A	Flare Type RT	N/A
N/A	Flare Slope LT (%)	N/A	N/A	Flare Slope RT (%)	0.0
N/A	Flare Traversable LT?	N/A	N/A	Flare Traversable RT?	N/A
N/A	Landing Length (in)	0.0	N/A	DWS Provided?	N/A
N/A	Landing Width (in)	0.0	N/A	DWS Contrast?	N/A
N/A	Landing Slope (%)	0.0	N/A	DWS Length (in)	N/A
N/A	Landing X Slope (%)	0.0	N/A	DWS Full Width?	N/A
N/A	Landing Curb? (Y/N)	N/A	N/A	DWS Offset LT (in)	N/A
N/A	Shared Landing?	N/A	N/A	DWS Offset RT (in)	N/A
N/A	Gutter Ponding?	0.0	N/A	Gutter Slope (%)	N/A
N/A	Gutter Lip Ht (in)	0.0	N/A	Gutter X Slope (%)	N/A
N/A	Painted X Walk1?	No		Road Slope (%)	0.3
	X Walk 1 Direction	To NW		Road X Slope (%)	0.7
	X Walk 1 Width (in)	N/A		Clear Space?	N/A

X Walk 1 Slope (%)	0.3	N/A	Clear Space to XWalk (in)	N/A
	X Walk 1 X Slope (%)	0.7	N/A	Storm Grate/Utility Hazard?	N/A
N/A	Ramp inside XWalk1?	N/A		Storm Grate/Utility Type	
N/A	Any Obstructions?	N/A			N/A
	Obstruction Type		Yes	Surface Condition? (G/P)	Good
			N/A	Curb Slope (%)	N/A

Possible Solutions:

Remove & Replace Entire Ramp.
