Access Compliance Report

Public Rights-of-Way

(Curb Ramps)

Intersection ID: 42736	Main Street: CONNELL_GREEN_DR	Cross Street: CALDWELL_FOREST_DR	Location: NE
ADA ID: C0D980E2D720	Ramp Type: BlendTrans1	Initial Pass/Fail: Pass	Overall Compliance: No
Severity Score: 10			
Codes/Mitigation Info/Possible Solution		Field Measurements/Component Compliance

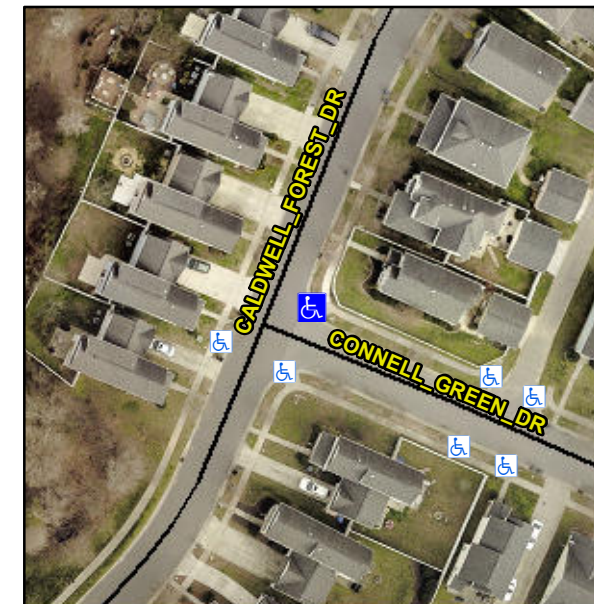
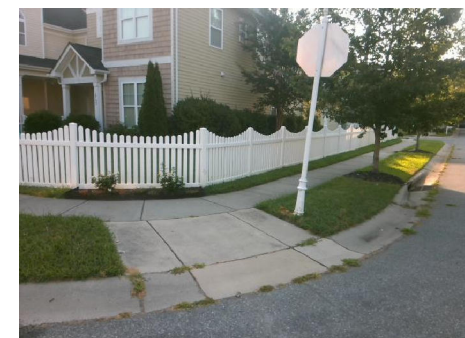
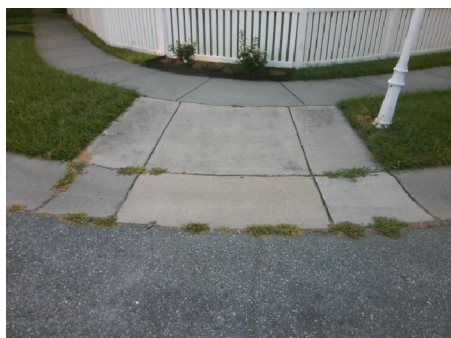
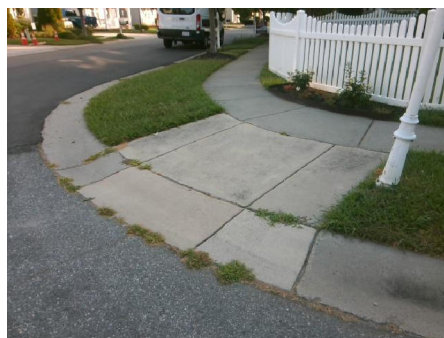
Not Found, R304.2.1, R304.5.3, R305

Compliance	Description	Data	Compliance	Description	Data
N/A	Ramp Length (in)	65.5	Yes	BlendTrans Slope (%)	4.3
Yes	Ramp Width (in)	51.0	Yes	BlendTrans XSlope (%)	1.6
N/A	Flare Type LT	Sloped	N/A	Flare Type RT	Sloped
N/A	Flare Slope LT (%)	3.1	N/A	Flare Slope RT (%)	4.5
N/A	Flare Traversable LT?	No	N/A	Flare Traversable RT?	No
Yes	Landing Length (in)	49.0	No	DWS Provided?	No
No	Landing Width (in)	40.0	N/A	DWS Contrast?	No
Yes	Landing Slope (%)	1.0	N/A	DWS Length (in)	N/A
No	Landing X Slope (%)	2.4	N/A	DWS Full Width?	No
N/A	Landing Curb? (Y/N)	No	N/A	DWS Offset (in)	N/A
N/A	Shared Landing?	No			
Yes	Gutter Ponding?	No	Yes	Gutter Slope (%)	0.2
Yes	Gutter Lip Ht (in)	0.0	Yes	Gutter X Slope (%)	1.9
N/A	Painted X Walk1?	No	N/A	Painted X Walk2?	No
	X Walk 1 Direction	To W		X Walk 2 Direction	To S
	X Walk 1 Width (in)	N/A		X Walk 2 Width (in)	N/A
	X Walk 1 Slope (%)	3.0		X Walk 2 Slope (%)	1.6
	X Walk 1 X Slope (%)	0.2		X Walk 2 X Slope (%)	0.9

N/A	Ramp inside XWalk1?	N/A	N/A	Ramp inside XWalk2?	N/A
	Road Slope (%)	0.4		Clear Space?	Yes
	Road X Slope (%)	1.4	N/A	Clear Space to XWalk (in)	N/A
Yes	Any Obstructions?	No	Yes	Storm Grate/Utility Hazard?	No
	Obstruction Type			Storm Grate/Utility Type	
		N/A			N/A
			Yes	Surface Condition? (G/P)	Good
			No	Curb Slope (%)	22.7

Possible Solutions:

Remove & Replace Curb Ramp With Two New Directional Ramps or Equivalent.
