Access Compliance Report Public Rights-of-Way (Curb Ramps)

Intersection ID: 4764 Main Street: ELDERBANK DR **Cross Street: TRINITY RD** Location: SW Initial Pass/Fail: Fail **Overall Compliance: No** 30 ADA ID: C0E115A8A731 Ramp Type: Perp **Severity Score:**

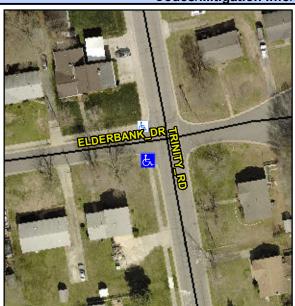
COCIDIO COIGNION		i iola ilio
Possible Solutions:	Compl	iance Description
Remove & Replace Entire Ramp.	N/A	Ramp Length (in)
·	No	Ramp Width (in)
	N/A	Flare Type LT
	N/A	Flare Slope LT (%)
	N/A	Flare Traversable LT
	N/A	Landing Length (in)
Surveyor Notes:	N/A	Landing Width (in)
N/A	N/A	Landing Slope (%)
	N/A	Landing X Slope (%)
	N/A	Landing Curb? (Y/N)
	N/A	Shared Landing?
PROW/ADA:	N/A	Gutter Ponding?
R304.5.1, R304.2.2	N/A	Gutter Lip Ht (in)
	N/A	Painted X Walk1?
		X Walk 1 Direction
	N/A	X Walk 1 Width (in)
		X Walk 1 Slope (%)
		X Walk 1 X Slope (%
	N/A	Ramp inside XWalk1
		Road Slope (%)

Curveyor Notes.			11/7
N/A			N/A
			N/A
			N/A
			N/A
PROW/ADA:			N/A
R304.5.1, R304.2.2			N/A
			N/A
			N/A
			N/A
Total Cost:	\$	1850.00	N/A
Total Cost.	Ψ	1030.00
