Access Compliance Report

Public Rights-of-Way

(Curb Ramps)

Intersection ID: 42472	Main Street: CASTLE_WATCH_AV	Cross Street: WINDSOR_CASTLE_LN	Location: NW
ADA ID: C0E30C145FB0	Ramp Type: PerpDiag	Initial Pass/Fail: Fail	Overall Compliance: No
Severity Score: 25			
Codes/Mitigation Info/Possible Solution		Field Measurements/Component Compliance

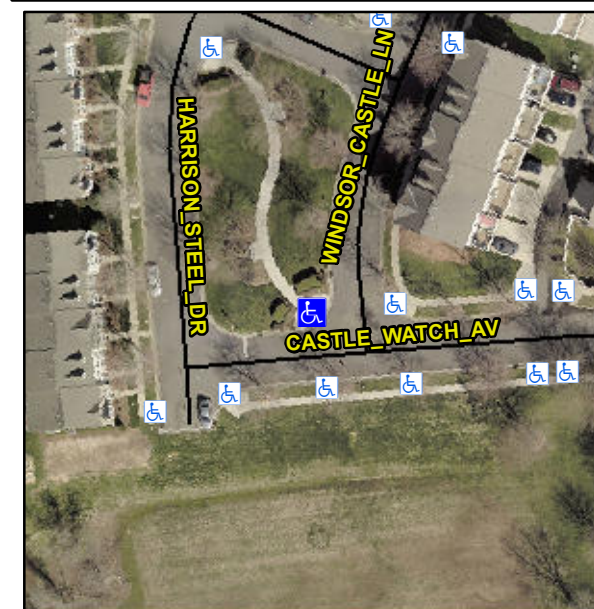
Compliance	Description	Data	Compliance	Description	Data
N/A	Ramp Length (in)	279.0	Yes	Ramp Slope (%)	12.4
Yes	Ramp Width (in)	60.0	Yes	Ramp XSlope (%)	2.0
N/A	Flare Type LT	N/A	N/A	Flare Type RT	N/A
N/A	Flare Slope LT (%)	N/A	N/A	Flare Slope RT (%)	N/A
N/A	Flare Traversable LT?	N/A	N/A	Flare Traversable RT?	N/A
N/A	Landing Length (in)	N/A	N/A	DWS Provided?	N/A
N/A	Landing Width (in)	N/A	N/A	DWS Contrast?	N/A
N/A	Landing Slope (%)	N/A	N/A	DWS Length (in)	N/A
N/A	Landing X Slope (%)	N/A	N/A	DWS Full Width?	N/A
N/A	Landing Curb? (Y/N)	N/A	N/A	DWS Offset (in)	N/A
N/A	Shared Landing?	N/A			
N/A	Gutter Ponding?	N/A	N/A	Gutter Slope (%)	N/A
N/A	Gutter Lip Ht (in)	N/A	N/A	Gutter X Slope (%)	N/A
N/A	Painted X Walk1?	No	N/A	Painted X Walk2?	No
	X Walk 1 Direction	To S		X Walk 2 Direction	To E
N/A	X Walk 1 Width (in)	N/A	N/A	X Walk 2 Width (in)	N/A
	X Walk 1 Slope (%)	0.5		X Walk 2 Slope (%)	4.3
	X Walk 1 X Slope (%)	4.0		X Walk 2 X Slope (%)	0.5

N/A	Ramp inside XWalk1?	N/A	N/A	Ramp inside XWalk2?	N/A
	Road Slope (%)	2.5	N/A	Clear Space?	N/A
	Road X Slope (%)	1.9	N/A	Clear Space to XWalk (in)	N/A
N/A	Any Obstructions?	N/A	N/A	Storm Grate/Utility Hazard?	N/A
	Obstruction Type			Storm Grate/Utility Type	
		N/A			N/A
			Yes	Surface Condition? (G/P)	Good

Remove & Replace Curb Ramp With Two New Directional Ramps or Equivalent.
