Access Compliance Report

Public Rights-of-Way

(Curb Ramps)

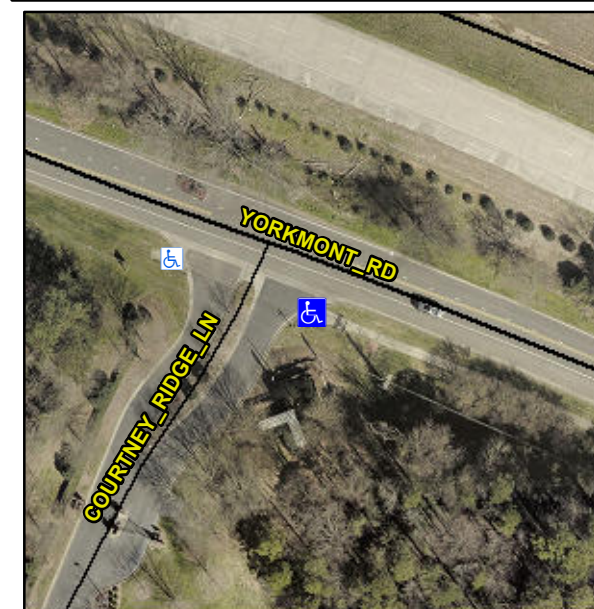
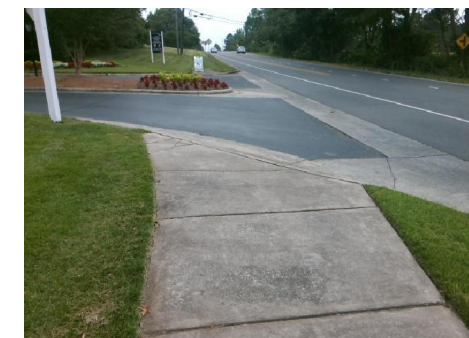
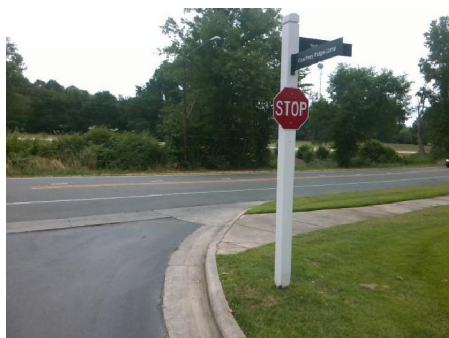
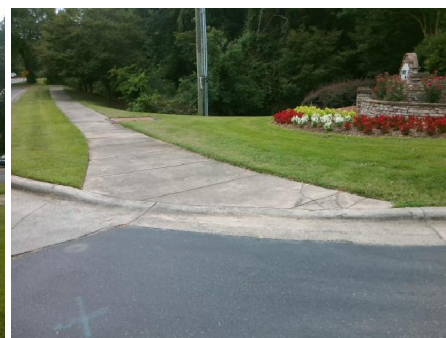
Intersection ID: N/A	Main Street: YORKMONT_RD	Cross Street: COURTNEY_RIDGE_LN	Location: SE
ADA ID: C0E86B390807	Ramp Type: Directional1	Initial Pass/Fail: Fail	Overall Compliance: No
Severity Score: 1.25			
Codes/Mitigation Info/Possible Solution		Field Measurements/Component Compliance

Compliance	Description	Data	Compliance	Description	Data
N/A	Ramp Length (in)	68.0	N/A	Grade Break?	N/A
Yes	Ramp Width (in)	70.0	N/A	Grade Break Slope (%)	0.0
Yes	Ramp Slope (%)	0.6	N/A	Grade Break XSlope (%)	0.0
No	Ramp XSlope (%)	4.2			
N/A	Flare Type LT	N/A	N/A	Flare Type RT	N/A
N/A	Flare Slope LT (%)	N/A	N/A	Flare Slope RT (%)	0.0
N/A	Flare Traversable LT?	N/A	N/A	Flare Traversable RT?	N/A
N/A	Landing Length (in)	0.0	N/A	DWS Provided?	N/A
N/A	Landing Width (in)	0.0	N/A	DWS Contrast?	N/A
N/A	Landing Slope (%)	0.0	N/A	DWS Length (in)	N/A
N/A	Landing X Slope (%)	0.0	N/A	DWS Full Width?	N/A
N/A	Landing Curb? (Y/N)	N/A	N/A	DWS Offset LT (in)	N/A
N/A	Shared Landing?	N/A	N/A	DWS Offset RT (in)	N/A
N/A	Gutter Ponding?	0.0	N/A	Gutter Slope (%)	N/A
N/A	Gutter Lip Ht (in)	0.0	N/A	Gutter X Slope (%)	N/A
N/A	Painted X Walk1?	No		Road Slope (%)	0.9
	X Walk 1 Direction	To W		Road X Slope (%)	4.0
	X Walk 1 Width (in)	N/A		Clear Space?	N/A

X Walk 1 Slope (%)	0.9	N/A	Clear Space to XWalk (in)	N/A
	X Walk 1 X Slope (%)	4.0	N/A	Storm Grate/Utility Hazard?	N/A
N/A	Ramp inside XWalk1?	N/A		Storm Grate/Utility Type	
N/A	Any Obstructions?	N/A			N/A
	Obstruction Type		Yes	Surface Condition? (G/P)	Good
			N/A	Curb Slope (%)	12.2

Possible Solutions:

Remove & Replace Entire Ramp.

R304.5.3

\$ 1600.00
