# Access Compliance Report

## Public Rights-of-Way

### (Curb Ramps)

Intersection ID: 47124	Main Street: GOLD_WORTHY_CT	Cross Street: EMMONS_LN	Location:	N
ADA ID: C10016516279	Ramp Type: PerpDiag	Initial Pass/Fail: Fail	Overall Compliance: No	Severity Score: 25
Codes/Mitigation Info/Possible Solution		Field Measurements/Component Compliance

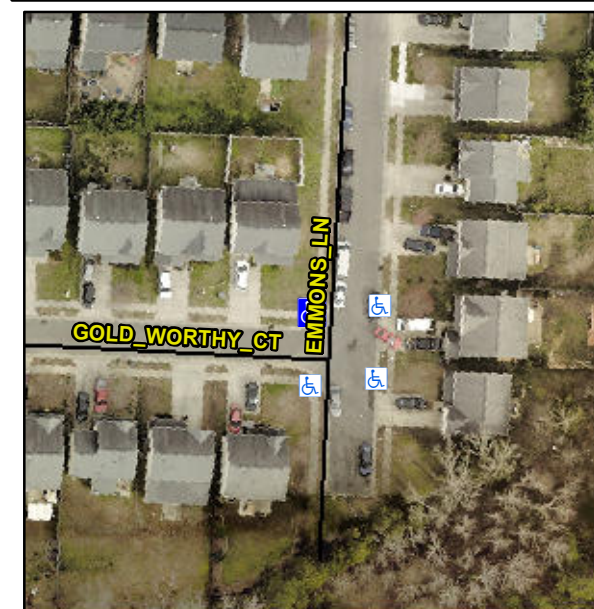
**Not Found, R304.5.3**

Compliance	Description	Data	Compliance	Description	Data
N/A	Ramp Length (in)	47.0	Yes	Ramp Slope (%)	6.7
Yes	Ramp Width (in)	48.0	No	Ramp XSlope (%)	7.9
N/A	Flare Type LT	N/A	N/A	Flare Type RT	N/A
N/A	Flare Slope LT (%)	N/A	N/A	Flare Slope RT (%)	N/A
N/A	Flare Traversable LT?	N/A	N/A	Flare Traversable RT?	N/A
N/A	Landing Length (in)	N/A	N/A	DWS Provided?	N/A
N/A	Landing Width (in)	N/A	N/A	DWS Contrast?	N/A
N/A	Landing Slope (%)	N/A	N/A	DWS Length (in)	N/A
N/A	Landing X Slope (%)	N/A	N/A	DWS Full Width?	N/A
N/A	Landing Curb? (Y/N)	N/A	N/A	DWS Offset (in)	N/A
N/A	Shared Landing?	N/A			
N/A	Gutter Ponding?	N/A	N/A	Gutter Slope (%)	N/A
N/A	Gutter Lip Ht (in)	N/A	N/A	Gutter X Slope (%)	N/A
N/A	Painted X Walk1?	No	N/A	Painted X Walk2?	No
	X Walk 1 Direction	To SW		X Walk 2 Direction	To SE
N/A	X Walk 1 Width (in)	N/A	N/A	X Walk 2 Width (in)	N/A
	X Walk 1 Slope (%)	5.8		X Walk 2 Slope (%)	1.2
	X Walk 1 X Slope (%)	4.1		X Walk 2 X Slope (%)	5.6

N/A	Ramp inside XWalk1?	N/A	N/A	Ramp inside XWalk2?	N/A
	Road Slope (%)	6.2	N/A	Clear Space?	N/A
	Road X Slope (%)	5.7	N/A	Clear Space to XWalk (in)	N/A
N/A	Any Obstructions?	N/A	N/A	Storm Grate/Utility Hazard?	N/A
	Obstruction Type			Storm Grate/Utility Type	
		N/A			N/A
		Yes		Surface Condition? (G/P)	Good

**Remove & Replace Curb Ramp With Two New Directional Ramps or Equivalent.**

Total Cost: \$ 3200.00
