Access Compliance Report

Public Rights-of-Way

(Curb Ramps)

Intersection ID: 18605	Main Street: MOCKINGBIRD_LN	Cross Street: PARK_RD	Location: SW
ADA ID: C103B1CC8810	Ramp Type: PerpDiag	Initial Pass/Fail: Fail	Overall Compliance: No
Severity Score: 10			
Codes/Mitigation Info/Possible Solution		Field Measurements/Component Compliance

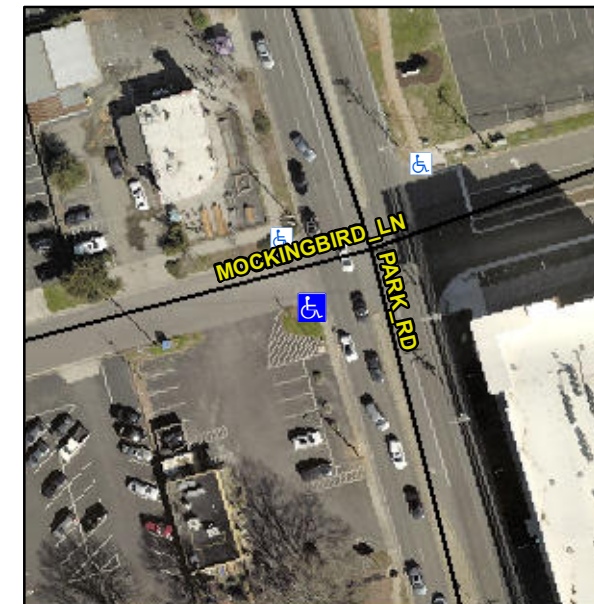
Compliance	Description	Data	Compliance	Description	Data
N/A	Ramp Length (in)	54.0	Yes	Ramp Slope (%)	5.7
No	Ramp Width (in)	47.0	No	Ramp XSlope (%)	3.2
N/A	Flare Type LT	N/A	N/A	Flare Type RT	N/A
N/A	Flare Slope LT (%)	N/A	N/A	Flare Slope RT (%)	N/A
N/A	Flare Traversable LT?	N/A	N/A	Flare Traversable RT?	N/A
N/A	Landing Length (in)	N/A	N/A	DWS Provided?	N/A
N/A	Landing Width (in)	N/A	N/A	DWS Contrast?	N/A
N/A	Landing Slope (%)	N/A	N/A	DWS Length (in)	N/A
N/A	Landing X Slope (%)	N/A	N/A	DWS Full Width?	N/A
N/A	Landing Curb? (Y/N)	N/A	N/A	DWS Offset (in)	N/A
N/A	Shared Landing?	N/A			
N/A	Gutter Ponding?	N/A	N/A	Gutter Slope (%)	N/A
N/A	Gutter Lip Ht (in)	N/A	N/A	Gutter X Slope (%)	N/A
N/A	Painted X Walk1?	No	N/A	Painted X Walk2?	No
	X Walk 1 Direction	To E		X Walk 2 Direction	To N
N/A	X Walk 1 Width (in)	N/A	N/A	X Walk 2 Width (in)	N/A
	X Walk 1 Slope (%)	1.3		X Walk 2 Slope (%)	3.4
	X Walk 1 X Slope (%)	3.8		X Walk 2 X Slope (%)	0.8

N/A	Ramp inside XWalk1?	N/A	N/A	Ramp inside XWalk2?	N/A
	Road Slope (%)	2.3	N/A	Clear Space?	N/A
	Road X Slope (%)	5.7	N/A	Clear Space to XWalk (in)	N/A
N/A	Any Obstructions?	N/A	N/A	Storm Grate/Utility Hazard?	N/A
	Obstruction Type			Storm Grate/Utility Type	
		N/A			N/A
			Yes	Surface Condition? (G/P)	Good

Remove & Replace Curb Ramp With Two New Directional Ramps or Equivalent.
