Access Compliance Report

Public Rights-of-Way

(Curb Ramps)

Intersection ID: 3219	Main Street: HAMPTON_PLACE_DR	Cross Street: SHADOW_PINE_DR	Location: NE
ADA ID: C10428899F90	Ramp Type: Perp	Initial Pass/Fail: Fail	Overall Compliance: No
Severity Score: 12.5			
Codes/Mitigation Info/Possible Solution		Field Measurements/Component Compliance

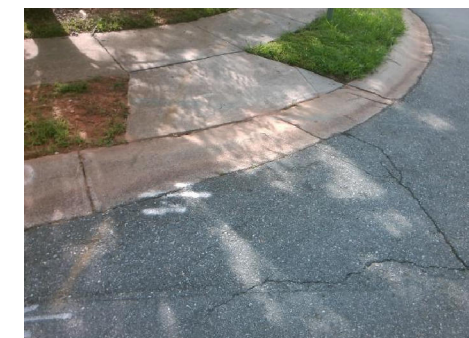
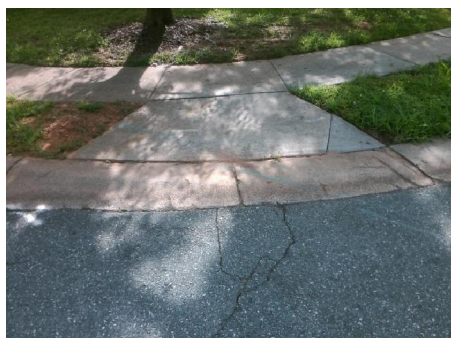
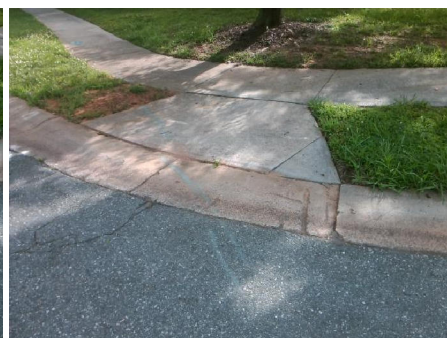
Not Found, R304.5.3

Compliance	Description	Data	Compliance	Description	Data
N/A	Ramp Length (in)	50.0	Yes	Ramp Slope (%)	6.2
Yes	Ramp Width (in)	59.0	No	Ramp XSlope (%)	5.7
N/A	Flare Type LT	N/A	N/A	Flare Type RT	N/A
N/A	Flare Slope LT (%)	N/A	N/A	Flare Slope RT (%)	N/A
N/A	Flare Traversable LT?	N/A	N/A	Flare Traversable RT?	N/A
N/A	Landing Length (in)	N/A	N/A	DWS Provided?	N/A
N/A	Landing Width (in)	N/A	N/A	DWS Contrast?	N/A
N/A	Landing Slope (%)	N/A	N/A	DWS Length (in)	N/A
N/A	Landing X Slope (%)	N/A	N/A	DWS Full Width?	N/A
N/A	Landing Curb? (Y/N)	N/A	N/A	DWS Offset (in)	N/A
N/A	Shared Landing?	N/A			
N/A	Gutter Ponding?	N/A	N/A	Gutter Slope (%)	N/A
N/A	Gutter Lip Ht (in)	N/A	N/A	Gutter X Slope (%)	N/A
N/A	Painted X Walk1?	No	N/A	Painted X Walk2?	N/A
	X Walk 1 Direction	To W		X Walk 2 Direction	N/A
N/A	X Walk 1 Width (in)	N/A	N/A	X Walk 2 Width (in)	N/A
	X Walk 1 Slope (%)	0.6		X Walk 2 Slope (%)	N/A
	X Walk 1 X Slope (%)	8.2		X Walk 2 X Slope (%)	N/A

N/A	Ramp inside XWalk1?	N/A	N/A	Ramp inside XWalk2?	N/A
	Road Slope (%)	N/A	N/A	Clear Space?	N/A
	Road X Slope (%)	N/A	N/A	Clear Space to XWalk (in)	N/A
N/A	Any Obstructions?	N/A	N/A	Storm Grate/Utility Hazard?	N/A
	Obstruction Type			Storm Grate/Utility Type	
		N/A			N/A
			Yes	Surface Condition? (G/P)	Good

Remove & Replace Entire Ramp.
