# Access Compliance Report

## Public Rights-of-Way

### (Curb Ramps)

Intersection ID: 13667	Main Street: E_7TH_ST	Cross Street: HAWTHORNE_LN	Location: E
ADA ID: C10C61299D95	Ramp Type: PerpDiag	Initial Pass/Fail: Fail	Overall Compliance: No
Severity Score: 12.5			
Codes/Mitigation Info/Possible Solution		Field Measurements/Component Compliance

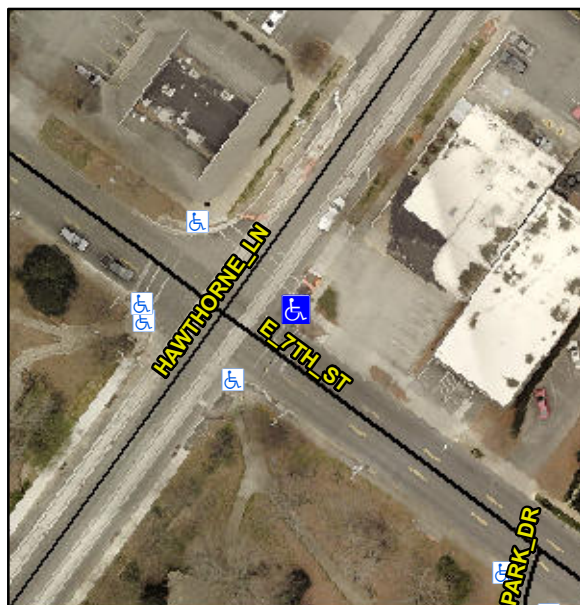
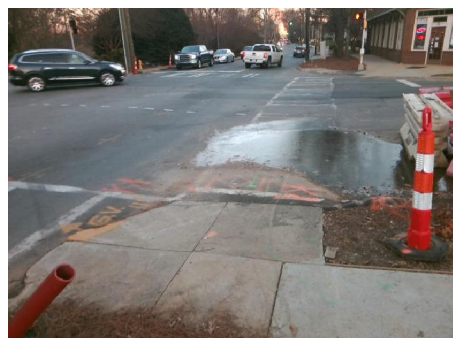
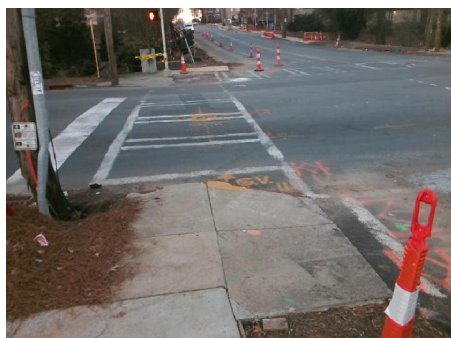
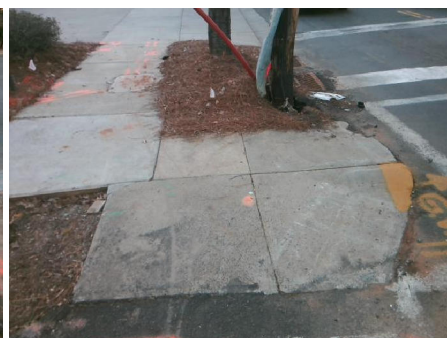
Compliance	Description	Data	Compliance	Description	Data
N/A	Ramp Length (in)	53.0	No	Ramp Slope (%)	10.1
Yes	Ramp Width (in)	48.0	Yes	Ramp XSlope (%)	1.8
N/A	Flare Type LT	N/A	N/A	Flare Type RT	N/A
N/A	Flare Slope LT (%)	N/A	N/A	Flare Slope RT (%)	N/A
N/A	Flare Traversable LT?	N/A	N/A	Flare Traversable RT?	N/A
N/A	Landing Length (in)	N/A	N/A	DWS Provided?	N/A
N/A	Landing Width (in)	N/A	N/A	DWS Contrast?	N/A
N/A	Landing Slope (%)	N/A	N/A	DWS Length (in)	N/A
N/A	Landing X Slope (%)	N/A	N/A	DWS Full Width?	N/A
N/A	Landing Curb? (Y/N)	N/A	N/A	DWS Offset (in)	N/A
N/A	Shared Landing?	N/A			
N/A	Gutter Ponding?	N/A	N/A	Gutter Slope (%)	N/A
N/A	Gutter Lip Ht (in)	N/A	N/A	Gutter X Slope (%)	N/A
N/A	Painted X Walk1?	Yes	N/A	Painted X Walk2?	Yes
	X Walk 1 Direction	To NW		X Walk 2 Direction	To SW
N/A	X Walk 1 Width (in)	75.0	N/A	X Walk 2 Width (in)	97.0
	X Walk 1 Slope (%)	3.1		X Walk 2 Slope (%)	3.3
	X Walk 1 X Slope (%)	0.1		X Walk 2 X Slope (%)	2.3

N/A	Ramp inside XWalk1?	Yes	N/A	Ramp inside XWalk2?	Yes
	Road Slope (%)	1.1	N/A	Clear Space?	N/A
	Road X Slope (%)	3.6	N/A	Clear Space to XWalk (in)	N/A
N/A	Any Obstructions?	N/A	N/A	Storm Grate/Utility Hazard?	N/A
	Obstruction Type			Storm Grate/Utility Type	
		N/A			N/A
		Yes		Surface Condition? (G/P)	Good

**Remove & Replace Curb Ramp With Two New Directional Ramps or Equivalent.**
