Access Compliance Report

Public Rights-of-Way

(Curb Ramps)

Intersection ID: 10022357	Main Street: CAMERON_VALLEY_PY	Cross Street: N/A	Location: SE
ADA ID: C10FCD57980D	Ramp Type: PerpDiag	Initial Pass/Fail: Fail	Overall Compliance: No
Severity Score: 42.5			
Codes/Mitigation Info/Possible Solution		Field Measurements/Component Compliance

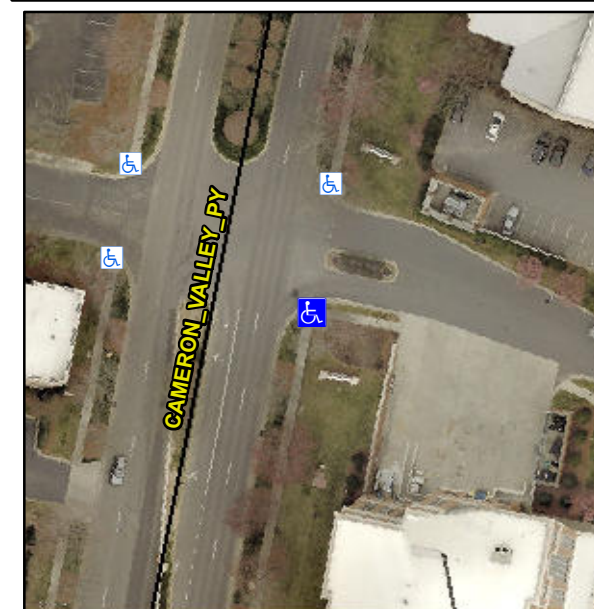
Compliance	Description	Data	Compliance	Description	Data
N/A	Ramp Length (in)	121.5	No	Ramp Slope (%)	17.1
No	Ramp Width (in)	33.5	Yes	Ramp XSlope (%)	1.3
N/A	Flare Type LT	N/A	N/A	Flare Type RT	N/A
N/A	Flare Slope LT (%)	N/A	N/A	Flare Slope RT (%)	N/A
N/A	Flare Traversable LT?	N/A	N/A	Flare Traversable RT?	N/A
N/A	Landing Length (in)	N/A	N/A	DWS Provided?	N/A
N/A	Landing Width (in)	N/A	N/A	DWS Contrast?	N/A
N/A	Landing Slope (%)	N/A	N/A	DWS Length (in)	N/A
N/A	Landing X Slope (%)	N/A	N/A	DWS Full Width?	N/A
N/A	Landing Curb? (Y/N)	N/A	N/A	DWS Offset (in)	N/A
N/A	Shared Landing?	N/A			
N/A	Gutter Ponding?	N/A	N/A	Gutter Slope (%)	N/A
N/A	Gutter Lip Ht (in)	N/A	N/A	Gutter X Slope (%)	N/A
N/A	Painted X Walk1?	No	N/A	Painted X Walk2?	No
	X Walk 1 Direction	To NE		X Walk 2 Direction	To NW
N/A	X Walk 1 Width (in)	N/A	N/A	X Walk 2 Width (in)	N/A
	X Walk 1 Slope (%)	3.4		X Walk 2 Slope (%)	3.9
	X Walk 1 X Slope (%)	3.1		X Walk 2 X Slope (%)	6.6

N/A	Ramp inside XWalk1?	N/A	N/A	Ramp inside XWalk2?	N/A
	Road Slope (%)	1.0	N/A	Clear Space?	N/A
	Road X Slope (%)	1.6	N/A	Clear Space to XWalk (in)	N/A
N/A	Any Obstructions?	N/A	N/A	Storm Grate/Utility Hazard?	N/A
	Obstruction Type			Storm Grate/Utility Type	
		N/A			N/A
			Yes	Surface Condition? (G/P)	Good

Remove & Replace Curb Ramp With Two New Directional Ramps or Equivalent.

R304.5.1, R304.2.2
