Intersection ID: 10025598		Main Street: E_WOODLAWN_RD		Cross Street: N/A		Location:		SE									
ADA ID: C1107582C437		Ramp Type: Combination1		Initial Pass/Fail: Fail		Overall Compliance: No		Severity Score: 85									
Codes/Mitigation Info/Possible Solution				Field Measurements/Component Compliance

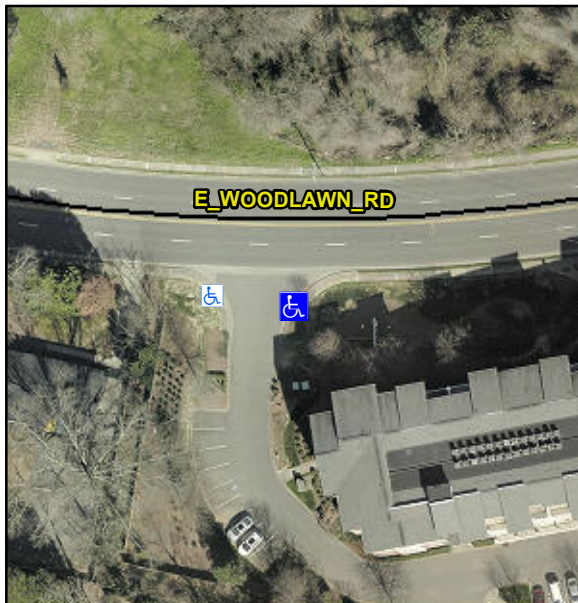
Possible Solutions:		Compliance		Description		Data		Compliance		Description		Data			
		Remove & Replace Entire Ramp.		N/A		Ramp Length LT (in)		80.0		N/A		Ramp Length RT (in)		66.0			
				No		Ramp Width LT (in)		28.0		No		Ramp Width RT (in)		28.0			
				Yes		Ramp Slope LT (%)		5.3		No		Ramp Slope RT (%)		13.7			
				No		Ramp XSlope LT (%)		3.5		No		Ramp XSlope RT (%)		4.2			
				N/A		Ramp Length (in)		32.0		Yes		Ramp Slope (%)		5.1			
				Yes		Ramp Width (in)		48.0		No		Ramp XSlope (%)		9.8			
				N/A		Flare Type LT		N/A		N/A		Flare Type RT		N/A			
				N/A		Flare Slope LT (%)		N/A		N/A		Flare Slope RT (%)		N/A

N/A		Flare Traversable LT?		N/A		N/A		Flare Traversable RT?		N/A			
<p>Surveyor Notes:</p> <p>N/A</p> <p>PROW/ADA:</p> <p>Not Found, R304.5.1, R304.5.3, R304.3.2</p>				N/A		Landing Length (in)		N/A		N/A		DWS Provided?		N/A			
				N/A		Landing Width (in)		N/A		N/A		DWS Contrast?		N/A			
				N/A		Landing Slope (%)		N/A		N/A		DWS Length (in)		N/A			
				N/A		Landing X Slope (%)		N/A		N/A		DWS Full Width?		N/A			
				N/A		Landing Curb? (Y/N)		N/A		N/A		DWS Offset (in)		N/A			
				N/A		Shared Landing?		N/A									
				N/A		Gutter Ponding?		N/A		N/A		Gutter Slope (%)		N/A			
				N/A		Gutter Lip Ht (in)		N/A		N/A		Gutter X Slope (%)		N/A			
				N/A		Painted X Walk1?		No		N/A		Painted X Walk2?		N/A			
						X Walk 1 Direction		To W				X Walk 2 Direction		N/A			
<p>Street 1 Name</p> <p>None</p> <p>Stop Condition-Street 1</p> <p>ENTRANCE</p> <p>Street 2 Name</p> <p>N/A</p> <p>Stop Condition-Street 2</p> <p>N/A</p> <p>Total Cost:</p> <p>\$ 1800.00</p>						X Walk 1 Width (in)		N/A				X Walk 2 Width (in)		N/A

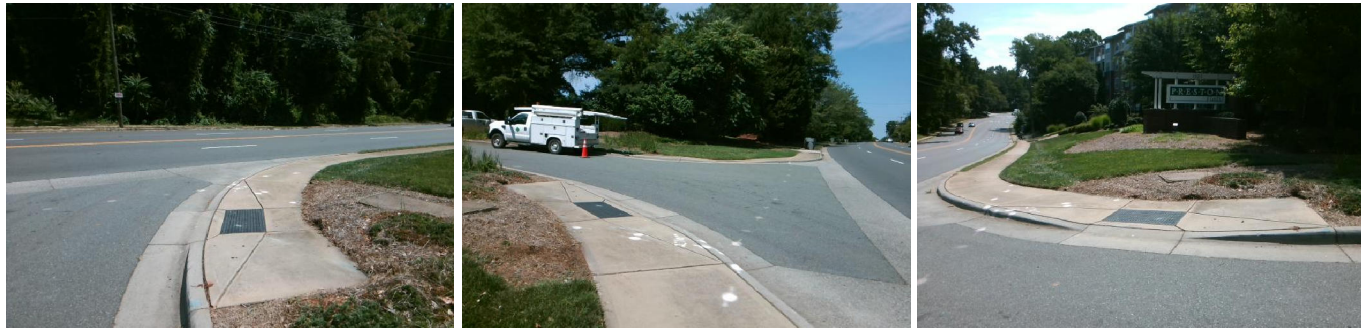
X Walk 1 Slope (%)		4.2				X Walk 2 Slope (%)		N/A			
						X Walk 1 X Slope (%)		7.7				X Walk 2 X Slope (%)		N/A			
				N/A		Ramp inside XWalk1?		N/A		N/A		Ramp inside XWalk2?		N/A			
						Road Slope (%)		N/A				Clear Space?		N/A			
						Road X Slope (%)		N/A		N/A		Clear Space to XWalk (in)		N/A			
												N/A		Any Obstruction?		N/A	
														Obstruction Type		N/A	
												N/A		Storm Grate/Utility Hazard?		N/A

Storm Grate/Utility Type		N/A			
				Yes		Surface Condition? (G/P)		Good									
												Curb Slope (%)		19.4
