Access Compliance Report

Public Rights-of-Way (Curb Ramps)

Intersection ID: 26714	Main Street: NANCY_CREEK_RD	Cross Street: OPEN_BOOK_LN	Location: NW
ADA ID: C114D1681F56	Ramp Type: BlendTrans1	Initial Pass/Fail: Fail	Overall Compliance: No
		Severity Score: 10

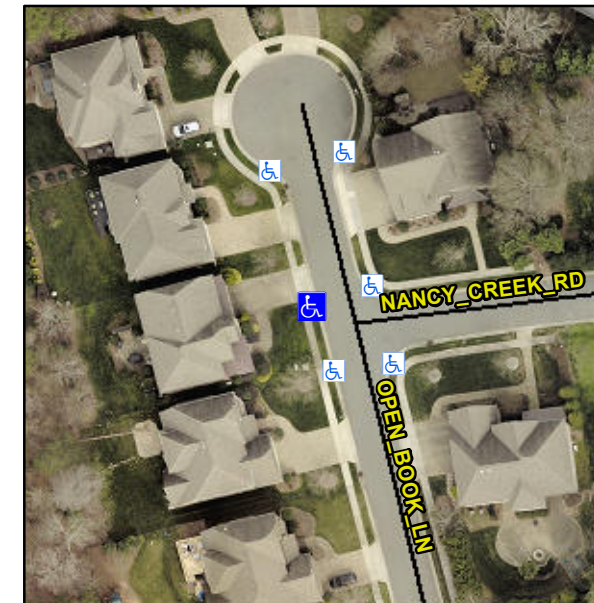
Compliance	Description	Data	Compliance	Description	Data
N/A	Ramp Length (in)	48.0	Yes	BlendTrans Slope (%)	3.1
No	Ramp Width (in)	47.5	Yes	BlendTrans XSlope (%)	3.2
N/A	Flare Type LT	N/A	N/A	Flare Type RT	N/A
N/A	Flare Slope LT (%)	N/A	N/A	Flare Slope RT (%)	N/A
N/A	Flare Traversable LT?	N/A	N/A	Flare Traversable RT?	N/A
N/A	Landing Length (in)	N/A	N/A	DWS Provided?	N/A
N/A	Landing Width (in)	N/A	N/A	DWS Contrast?	N/A
N/A	Landing Slope (%)	N/A	N/A	DWS Length (in)	N/A
N/A	Landing X Slope (%)	N/A	N/A	DWS Full Width?	N/A
N/A	Landing Curb? (Y/N)	N/A	N/A	DWS Offset (in)	N/A
N/A	Shared Landing?	N/A			
N/A	Gutter Ponding?	N/A	N/A	Gutter Slope (%)	N/A
N/A	Gutter Lip Ht (in)	N/A	N/A	Gutter X Slope (%)	N/A
N/A	Painted X Walk1?	No	N/A	Painted X Walk2?	N/A
	X Walk 1 Direction	To E		X Walk 2 Direction	N/A
	X Walk 1 Width (in)	N/A		X Walk 2 Width (in)	N/A
	X Walk 1 Slope (%)	3.2		X Walk 2 Slope (%)	N/A
	X Walk 1 X Slope (%)	5.4		X Walk 2 X Slope (%)	N/A

N/A	Ramp inside XWalk1?	N/A	N/A	Ramp inside XWalk2?	N/A
	Road Slope (%)	5.4		Clear Space?	N/A
	Road X Slope (%)	3.2	N/A	Clear Space to XWalk (in)	N/A
N/A	Any Obstructions?	N/A	N/A	Storm Grate/Utility Hazard?	N/A
	Obstruction Type			Storm Grate/Utility Type	
		N/A			N/A
			Yes	Surface Condition? (G/P)	Good
			No	Curb Slope (%)	18.2

Remove & Replace Curb Ramp With Two New Directional Ramps or Equivalent.
