Access Compliance Report Public Rights-of-Way (Curb Ramps)

Intersection ID: 11239 Main Street: DELGANY DR **Cross Street: MCKELVEY ST** Location: SE ADA ID: C1157F60EF59 Ramp Type: BlendTrans1 Initial Pass/Fail: Fail **Overall Compliance: No Severity Score:** 8.75

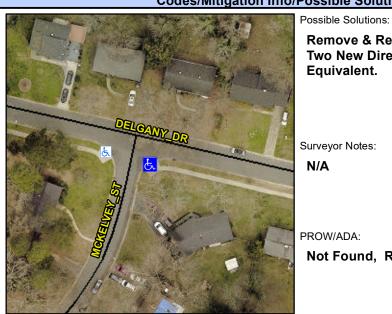
Not Found, R304.5.1

Field Measurements/Component Compliance							
	Compliance Description		Data	Compliance Description		Data	
	N/A	Ramp Length (in)	72.0	Yes	BlendTrans Slope (%)	3.0	
	No	Ramp Width (in)	47.5	Yes	BlendTrans XSlope (%)	0.1	
	N/A	Flare Type LT	N/A	N/A	Flare Type RT	N/A	
	N/A	Flare Slope LT (%)	N/A	N/A	Flare Slope RT (%)	N/A	
	N/A	Flare Traversable LT?	N/A	N/A	Flare Traversable RT?	N/A	
	N/A	Landing Length (in)	N/A	N/A	DWS Provided?	N/A	
	N/A	Landing Width (in)	N/A	N/A	DWS Contrast?	N/A	
	N/A	Landing Slope (%)	N/A	N/A	DWS Length (in)	N/A	
	N/A	Landing X Slope (%)	N/A	N/A	DWS Full Width?	N/A	
	N/A	Landing Curb? (Y/N)	N/A	N/A	DWS Offset (in)	N/A	
	N/A	Shared Landing?	N/A				
	N/A	Gutter Ponding?	N/A	N/A	Gutter Slope (%)	N/A	
	N/A	Gutter Lip Ht (in)	0.5	N/A	Gutter X Slope (%)	N/A	
	N/A	Painted X Walk1?	No	N/A	Painted X Walk2?	N/A	
		X Walk 1 Direction	To W		X Walk 2 Direction	N/A	
		X Walk 1 Width (in)	N/A		X Walk 2 Width (in)	N/A

X Walk 1 Slope (%)	0.7		X Walk 2 Slope (%)	N/A	
		X Walk 1 X Slope (%)	0.1		X Walk 2 X Slope (%)	N/A	
	N/A	Ramp inside XWalk1?	N/A	N/A	Ramp inside XWalk2?	N/A	
		Road Slope (%)	0.1		Clear Space?	N/A	
		Road X Slope (%)	0.7	N/A	Clear Space to XWalk (in)	N/A	
	N/A	Any Obstructions?	N/A	N/A	Storm Grate/Utility Hazard?	N/A	
		Obstruction Type			Storm Grate/Utility Type		
			N/A			N/A	
				Yes	Surface Condition? (G/P)	Good	
Š				No	Curb Slope (%)	24.6

Remove & Replace Curb Ramp With **Two New Directional Ramps or** Equivalent.
