Access Compliance Report

Public Rights-of-Way

(Curb Ramps)

Intersection ID: 49151	Main Street: DACAVIN_DR	Cross Street: VIDAL_LN	Location: NW
ADA ID: C11ADDEDC186	Ramp Type: ParaDiag	Initial Pass/Fail: Fail	Overall Compliance: No
			Severity Score: 33.75

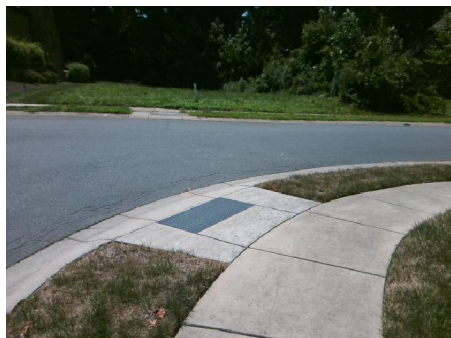
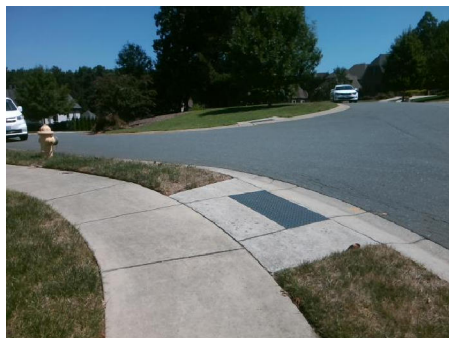
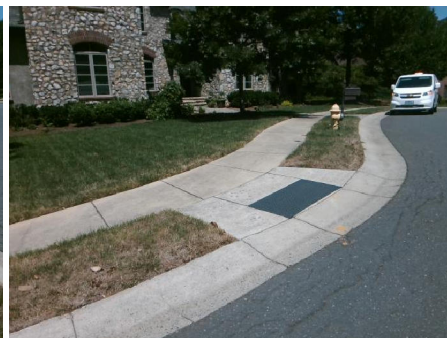
Compliance	Description	Data	Compliance	Description	Data
N/A	Ramp Length LT (in)	42.0	N/A	Ramp Length RT (in)	37.0
No	Ramp Width LT (in)	46.5	Yes	Ramp Width RT (in)	48.0
No	Ramp Slope LT (%)	12.7	Yes	Ramp Slope RT (%)	7.0
Yes	Ramp XSlope LT (%)	1.2	Yes	Ramp XSlope RT (%)	0.8
N/A	Landing Length (in)	N/A	N/A	DWS Provided?	N/A
N/A	Landing Width (in)	N/A	N/A	DWS Contrast?	N/A
N/A	Landing Slope (%)	N/A	N/A	DWS Length (in)	N/A
N/A	Landing X Slope (%)	N/A	N/A	DWS Full Width?	N/A
N/A	Landing Curb? (Y/N)	N/A	N/A	DWS Offset (in)	N/A
N/A	Shared Landing?	N/A			
N/A	Gutter Ponding?	N/A	N/A	Gutter Slope (%)	N/A
N/A	Gutter Lip Ht (in)	N/A	N/A	Gutter X Slope (%)	N/A
N/A	Painted X Walk1?	No	N/A	Painted X Walk2?	No
	X Walk 1 Direction	To S		X Walk 2 Direction	To E
N/A	X Walk 1 Width (in)	N/A	N/A	X Walk 2 Width (in)	N/A
	X Walk 1 Slope (%)	0.2		X Walk 2 Slope (%)	5.6
	X Walk 1 X Slope (%)	11.1		X Walk 2 X Slope (%)	0.3
N/A	Ramp inside XWalk1?	N/A	N/A	Ramp inside XWalk2?	N/A

Road Slope (%)	5.5	N/A	Clear Space?	N/A
	Road X Slope (%)	7.0	N/A	Clear Space to XWalk (in)	N/A
N/A	Any Obstructions?	N/A	N/A	Storm Grate/Utility Hazard?	N/A
	Obstruction Type			Storm Grate/Utility Type	
		N/A			N/A
			Yes	Surface Condition? (G/P)	Good
			N/A	Curb Slope (%)	9.5

Remove & Replace Curb Ramp With Two New Directional Ramps or Equivalent.
