Access Compliance Report

Public Rights-of-Way

(Curb Ramps)

Intersection ID: 13368	Main Street: CENTRAL_AV	Cross Street: LOGIE_AV	Location: NW
ADA ID: C11ED56A9C3A	Ramp Type: Perp	Initial Pass/Fail: Fail	Overall Compliance: No
Severity Score: 36.25			
Codes/Mitigation Info/Possible Solution		Field Measurements/Component Compliance

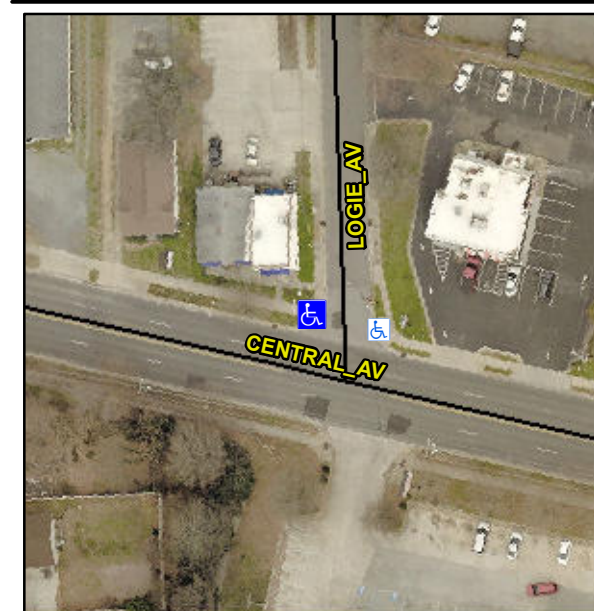
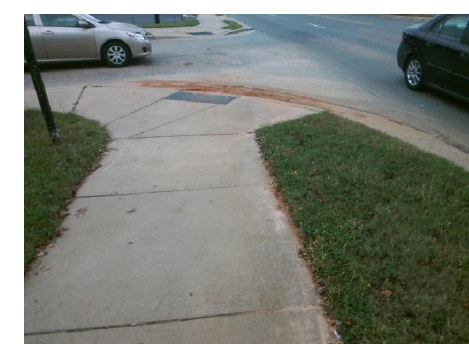
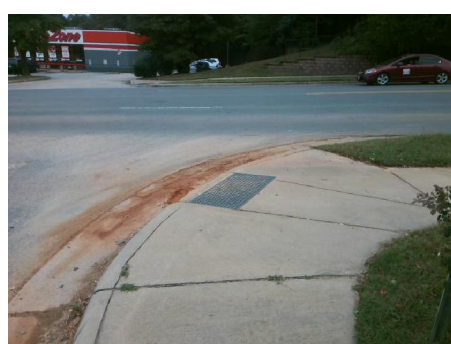
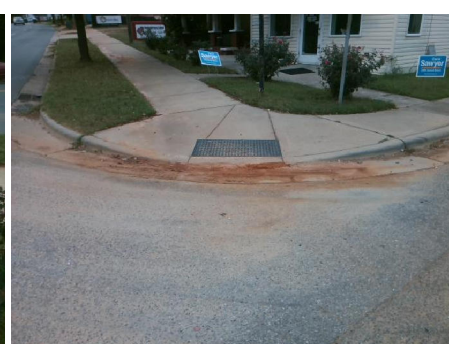
Not Found, R304.5.1, R304.5.3

Compliance	Description	Data	Compliance	Description	Data
N/A	Ramp Length (in)	93.0	Yes	Ramp Slope (%)	8.3
No	Ramp Width (in)	31.0	No	Ramp XSlope (%)	2.4
N/A	Flare Type LT	N/A	N/A	Flare Type RT	N/A
N/A	Flare Slope LT (%)	N/A	N/A	Flare Slope RT (%)	N/A
N/A	Flare Traversable LT?	N/A	N/A	Flare Traversable RT?	N/A
N/A	Landing Length (in)	N/A	N/A	DWS Provided?	N/A
N/A	Landing Width (in)	N/A	N/A	DWS Contrast?	N/A
N/A	Landing Slope (%)	N/A	N/A	DWS Length (in)	N/A
N/A	Landing X Slope (%)	N/A	N/A	DWS Full Width?	N/A
N/A	Landing Curb? (Y/N)	N/A	N/A	DWS Offset (in)	N/A
N/A	Shared Landing?	N/A			
N/A	Gutter Ponding?	Yes	N/A	Gutter Slope (%)	N/A
N/A	Gutter Lip Ht (in)	N/A	N/A	Gutter X Slope (%)	N/A
N/A	Painted X Walk1?	No	N/A	Painted X Walk2?	N/A
	X Walk 1 Direction	To SE		X Walk 2 Direction	N/A
N/A	X Walk 1 Width (in)	N/A	N/A	X Walk 2 Width (in)	N/A
	X Walk 1 Slope (%)	1.9		X Walk 2 Slope (%)	N/A
	X Walk 1 X Slope (%)	2.2		X Walk 2 X Slope (%)	N/A

N/A	Ramp inside XWalk1?	N/A	N/A	Ramp inside XWalk2?	N/A
	Road Slope (%)	N/A	N/A	Clear Space?	N/A
	Road X Slope (%)	N/A	N/A	Clear Space to XWalk (in)	N/A
N/A	Any Obstructions?	N/A	N/A	Storm Grate/Utility Hazard?	N/A
	Obstruction Type			Storm Grate/Utility Type	
		N/A			N/A
		Yes		Surface Condition? (G/P)	Good

Possible Solutions:

Remove & Replace Entire Ramp.
