Access Compliance Report

Public Rights-of-Way

(Curb Ramps)

Intersection ID: N/A	Main Street: CITY_PARK_DR	Cross Street: TYVOLA_RD	Location: NE
ADA ID: C125D9113E62	Ramp Type: MedianPerp	Initial Pass/Fail: Fail	Overall Compliance: No
Codes/Mitigation Info/Possible Solution		Field Measurements/Component Compliance

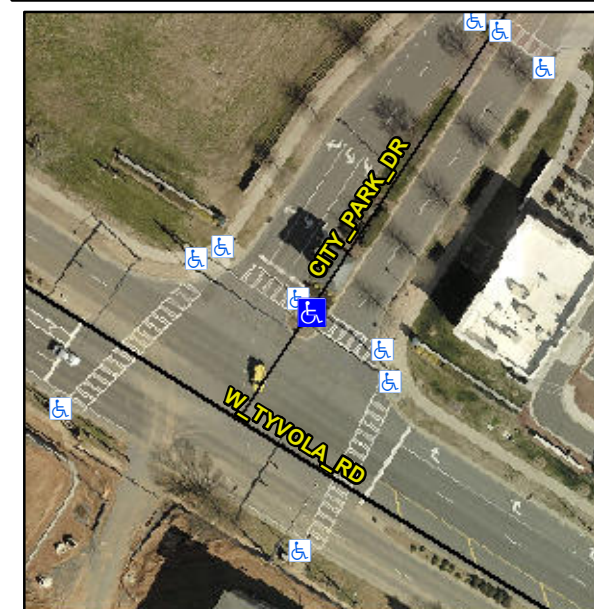
Not Found, R304.2.2, R304.5.3

Compliance	Description	Data	Compliance	Description	Data
N/A	Ramp Length (in)	72.0	No	Ramp Slope (%)	8.8
Yes	Ramp Width (in)	118.0	No	Ramp XSlope (%)	2.1
N/A	Flare Type LT	N/A	N/A	Flare Type RT	N/A
N/A	Flare Slope LT (%)	N/A	N/A	Flare Slope RT (%)	N/A
N/A	Flare Traversable LT?	N/A	N/A	Flare Traversable RT?	N/A
N/A	Landing Length (in)	N/A	N/A	DWS Provided?	N/A
N/A	Landing Width (in)	N/A	N/A	DWS Contrast?	N/A
N/A	Landing Slope (%)	N/A	N/A	DWS Length (in)	N/A
N/A	Landing X Slope (%)	N/A	N/A	DWS Full Width?	N/A
N/A	Landing Curb? (Y/N)	N/A	N/A	DWS Offset (in)	N/A
N/A	Shared Landing?	N/A			
N/A	Gutter Ponding?	N/A	N/A	Gutter Slope (%)	N/A
N/A	Gutter Lip Ht (in)	N/A	N/A	Gutter X Slope (%)	N/A
N/A	Painted X Walk1?	Yes	N/A	Painted X Walk2?	N/A
	X Walk 1 Direction	To SE		X Walk 2 Direction	N/A
N/A	X Walk 1 Width (in)	113.0	N/A	X Walk 2 Width (in)	N/A
	X Walk 1 Slope (%)	0.2		X Walk 2 Slope (%)	N/A
	X Walk 1 X Slope (%)	0.1		X Walk 2 X Slope (%)	N/A

N/A	Ramp inside XWalk1?	Yes	N/A	Ramp inside XWalk2?	N/A
	Road Slope (%)	N/A	N/A	Clear Space?	N/A
	Road X Slope (%)	N/A	N/A	Clear Space to XWalk (in)	N/A
N/A	Any Obstructions?	N/A	N/A	Storm Grate/Utility Hazard?	N/A
	Obstruction Type			Storm Grate/Utility Type	
		N/A			N/A
			Yes	Surface Condition? (G/P)	Good

Remove & Replace Entire Ramp.

Total Cost: \$ 1650.00
