# Access Compliance Report

## Public Rights-of-Way

### (Curb Ramps)

Intersection ID: 29962	Main Street: CANIPE_DR	Cross Street: WOODLAND_HILLS_RD	Location: S
ADA ID: C12B87793ABC	Ramp Type: PerpDiag	Initial Pass/Fail: Fail	Overall Compliance: No
Severity Score: 21.25			
Codes/Mitigation Info/Possible Solution		Field Measurements/Component Compliance

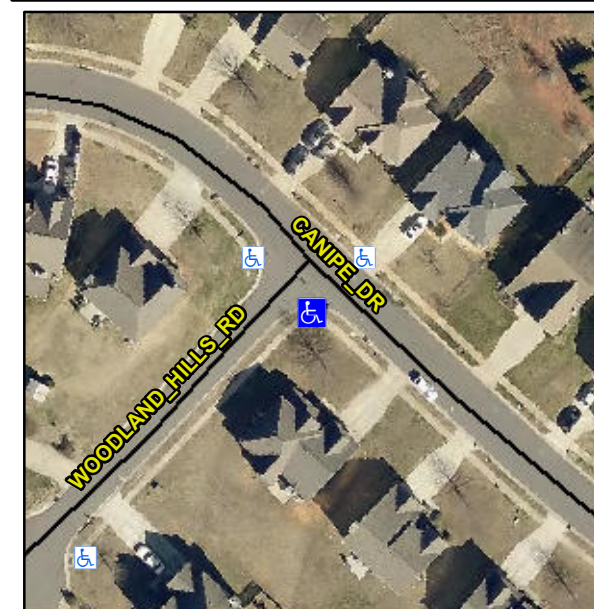
Compliance	Description	Data	Compliance	Description	Data
N/A	Ramp Length (in)	49.5	No	Ramp Slope (%)	10.2
No	Ramp Width (in)	38.0	Yes	Ramp XSlope (%)	0.8
N/A	Flare Type LT	N/A	N/A	Flare Type RT	N/A
N/A	Flare Slope LT (%)	N/A	N/A	Flare Slope RT (%)	N/A
N/A	Flare Traversable LT?	N/A	N/A	Flare Traversable RT?	N/A
N/A	Landing Length (in)	N/A	N/A	DWS Provided?	N/A
N/A	Landing Width (in)	N/A	N/A	DWS Contrast?	N/A
N/A	Landing Slope (%)	N/A	N/A	DWS Length (in)	N/A
N/A	Landing X Slope (%)	N/A	N/A	DWS Full Width?	N/A
N/A	Landing Curb? (Y/N)	N/A	N/A	DWS Offset (in)	N/A
N/A	Shared Landing?	N/A			
N/A	Gutter Ponding?	N/A	N/A	Gutter Slope (%)	N/A
N/A	Gutter Lip Ht (in)	N/A	N/A	Gutter X Slope (%)	N/A
N/A	Painted X Walk1?	No	N/A	Painted X Walk2?	No
	X Walk 1 Direction	To N		X Walk 2 Direction	To W
N/A	X Walk 1 Width (in)	N/A	N/A	X Walk 2 Width (in)	N/A
	X Walk 1 Slope (%)	0.1		X Walk 2 Slope (%)	0.3
	X Walk 1 X Slope (%)	2.3		X Walk 2 X Slope (%)	1.9

N/A	Ramp inside XWalk1?	N/A	N/A	Ramp inside XWalk2?	N/A
	Road Slope (%)	0.9	N/A	Clear Space?	N/A
	Road X Slope (%)	1.9	N/A	Clear Space to XWalk (in)	N/A
N/A	Any Obstructions?	N/A	N/A	Storm Grate/Utility Hazard?	N/A
	Obstruction Type			Storm Grate/Utility Type	
		N/A			N/A
			Yes	Surface Condition? (G/P)	Good

**Remove & Replace Curb Ramp With Two New Directional Ramps or Equivalent.**

**R304.5.1, R304.2.2**

Total Cost: \$ 3200.00
