Access Compliance Report

Public Rights-of-Way

(Curb Ramps)

Intersection ID: 2815	Main Street: BABERTON_CT	Cross Street: DUNOON_LN	Location: W
ADA ID: C12F72F8EA4E	Ramp Type: PerpDiag	Initial Pass/Fail: Fail	Overall Compliance: No
Codes/Mitigation Info/Possible Solution		Field Measurements/Component Compliance	
Severity Score: 33.75

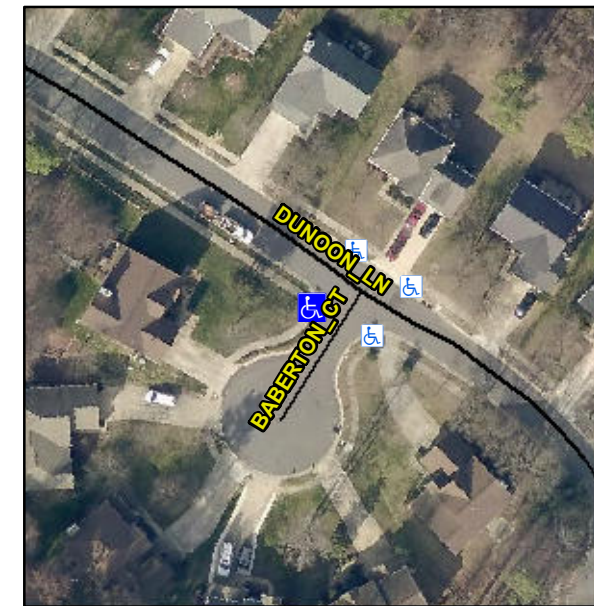
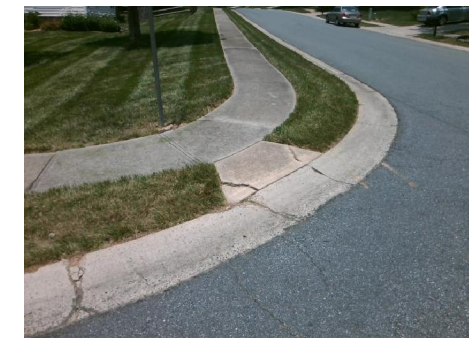
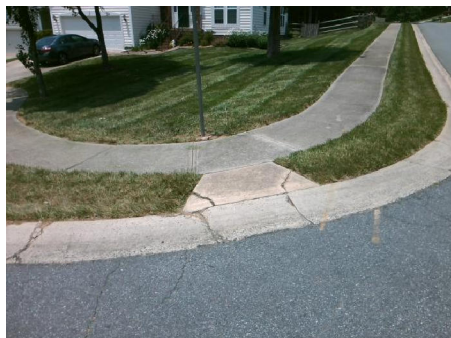
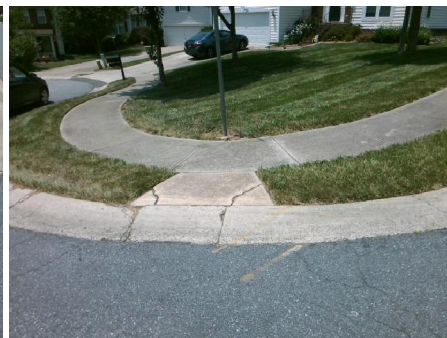
Not Found, R304.5.1, R304.2.2, R304.5.3

Compliance	Description	Data	Compliance	Description	Data
N/A	Ramp Length (in)	30.0	No	Ramp Slope (%)	8.6
No	Ramp Width (in)	36.0	No	Ramp XSlope (%)	5.4
N/A	Flare Type LT	N/A	N/A	Flare Type RT	N/A
N/A	Flare Slope LT (%)	N/A	N/A	Flare Slope RT (%)	N/A
N/A	Flare Traversable LT?	N/A	N/A	Flare Traversable RT?	N/A
N/A	Landing Length (in)	N/A	N/A	DWS Provided?	N/A
N/A	Landing Width (in)	N/A	N/A	DWS Contrast?	N/A
N/A	Landing Slope (%)	N/A	N/A	DWS Length (in)	N/A
N/A	Landing X Slope (%)	N/A	N/A	DWS Full Width?	N/A
N/A	Landing Curb? (Y/N)	N/A	N/A	DWS Offset (in)	N/A
N/A	Shared Landing?	N/A			
N/A	Gutter Ponding?	N/A	N/A	Gutter Slope (%)	N/A
N/A	Gutter Lip Ht (in)	N/A	N/A	Gutter X Slope (%)	N/A
N/A	Painted X Walk1?	No	N/A	Painted X Walk2?	No
	X Walk 1 Direction	To SE		X Walk 2 Direction	To NE
N/A	X Walk 1 Width (in)	N/A	N/A	X Walk 2 Width (in)	N/A
	X Walk 1 Slope (%)	0.1		X Walk 2 Slope (%)	5.2
	X Walk 1 X Slope (%)	9.0		X Walk 2 X Slope (%)	0.7

N/A	Ramp inside XWalk1?	N/A	N/A	Ramp inside XWalk2?	N/A
	Road Slope (%)	5.1	N/A	Clear Space?	N/A
	Road X Slope (%)	5.4	N/A	Clear Space to XWalk (in)	N/A
N/A	Any Obstructions?	N/A	N/A	Storm Grate/Utility Hazard?	N/A
	Obstruction Type			Storm Grate/Utility Type	
		N/A			N/A
			Yes	Surface Condition? (G/P)	Good

Remove & Replace Curb Ramp With Two New Directional Ramps or Equivalent.

Total Cost: \$ 3200.00
