Access Compliance Report

Public Rights-of-Way (Curb Ramps)

Intersection ID: 2952	Main Street: CREEK_BREEZE_RD	Cross Street: GREEN_PASTURE_RD	Location:	N
ADA ID: C12FBBADB53	Ramp Type: PerpDiag	Initial Pass/Fail: Fail	Overall Compliance: No	Severity Score: 12.5
Codes/Mitigation Info/Possible Solution		Field Measurements/Component Compliance

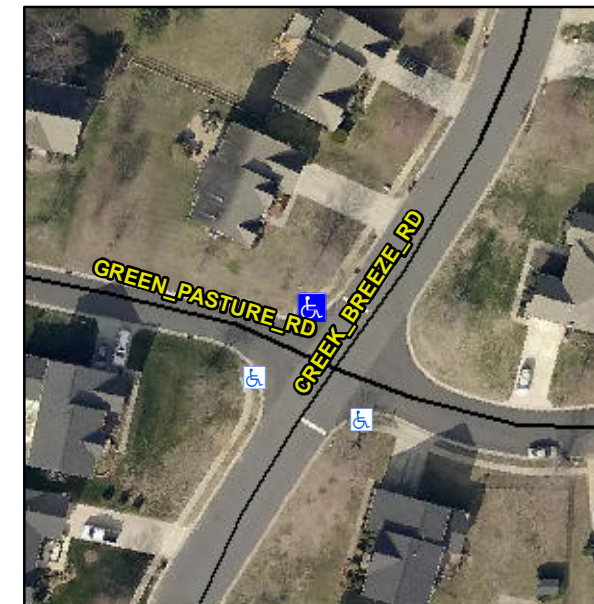
Not Found, R304.2.2

Compliance	Description	Data	Compliance	Description	Data
N/A	Ramp Length (in)	45.0	No	Ramp Slope (%)	10.3
Yes	Ramp Width (in)	68.0	Yes	Ramp XSlope (%)	0.6
N/A	Flare Type LT	N/A	N/A	Flare Type RT	N/A
N/A	Flare Slope LT (%)	N/A	N/A	Flare Slope RT (%)	N/A
N/A	Flare Traversable LT?	N/A	N/A	Flare Traversable RT?	N/A
N/A	Landing Length (in)	N/A	N/A	DWS Provided?	N/A
N/A	Landing Width (in)	N/A	N/A	DWS Contrast?	N/A
N/A	Landing Slope (%)	N/A	N/A	DWS Length (in)	N/A
N/A	Landing X Slope (%)	N/A	N/A	DWS Full Width?	N/A
N/A	Landing Curb? (Y/N)	N/A	N/A	DWS Offset (in)	N/A
N/A	Shared Landing?	N/A			
N/A	Gutter Ponding?	N/A	N/A	Gutter Slope (%)	N/A
N/A	Gutter Lip Ht (in)	N/A	N/A	Gutter X Slope (%)	N/A
N/A	Painted X Walk1?	No	N/A	Painted X Walk2?	No
	X Walk 1 Direction	To SW		X Walk 2 Direction	To SW
N/A	X Walk 1 Width (in)	N/A	N/A	X Walk 2 Width (in)	N/A
	X Walk 1 Slope (%)	1.8		X Walk 2 Slope (%)	0.3
	X Walk 1 X Slope (%)	0.9		X Walk 2 X Slope (%)	0.8

Possible Solutions:

Remove & Replace Curb Ramp With Two New Directional Ramps or Equivalent.
