Access Compliance Report

Public Rights-of-Way

(Curb Ramps)

Intersection ID: 29473	Main Street: HAWTHORNE BRIDGE CT	Cross Street: HAWTHORNE LN	Location: NW
ADA ID: C13412A435BF	Ramp Type: BlendTrans1	Initial Pass/Fail: Fail	Overall Compliance: No
		Severity Score: 25

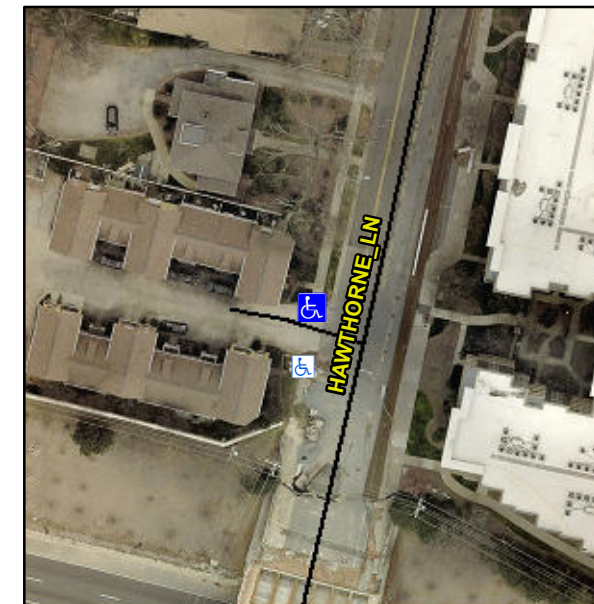
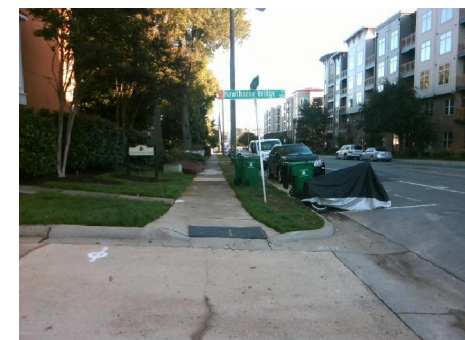
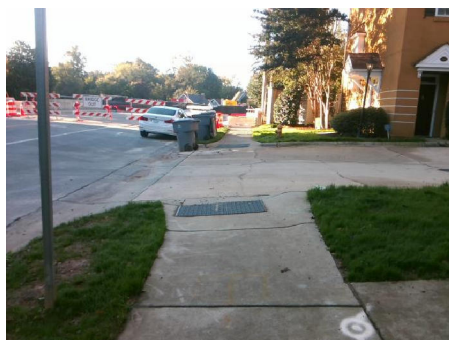
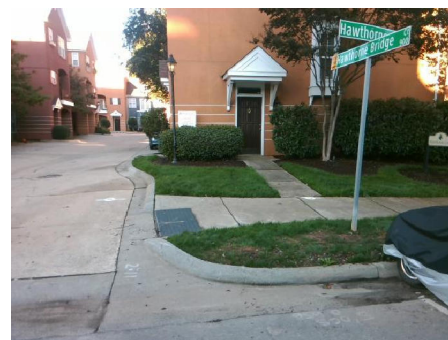
Compliance	Description	Data	Compliance	Description	Data
N/A	Ramp Length (in)	49.5	Yes	BlendTrans Slope (%)	1.7
Yes	Ramp Width (in)	48.0	No	BlendTrans XSlope (%)	9.2
N/A	Flare Type LT	N/A	N/A	Flare Type RT	N/A
N/A	Flare Slope LT (%)	N/A	N/A	Flare Slope RT (%)	N/A
N/A	Flare Traversable LT?	N/A	N/A	Flare Traversable RT?	N/A
N/A	Landing Length (in)	N/A	N/A	DWS Provided?	N/A
N/A	Landing Width (in)	N/A	N/A	DWS Contrast?	N/A
N/A	Landing Slope (%)	N/A	N/A	DWS Length (in)	N/A
N/A	Landing X Slope (%)	N/A	N/A	DWS Full Width?	N/A
N/A	Landing Curb? (Y/N)	N/A	N/A	DWS Offset (in)	N/A
N/A	Shared Landing?	N/A			
N/A	Gutter Ponding?	N/A	N/A	Gutter Slope (%)	N/A
N/A	Gutter Lip Ht (in)	N/A	N/A	Gutter X Slope (%)	N/A
N/A	Painted X Walk1?	No	N/A	Painted X Walk2?	N/A
	X Walk 1 Direction	To S		X Walk 2 Direction	N/A
	X Walk 1 Width (in)	N/A		X Walk 2 Width (in)	N/A
	X Walk 1 Slope (%)	0.3		X Walk 2 Slope (%)	N/A
	X Walk 1 X Slope (%)	8.5		X Walk 2 X Slope (%)	N/A

N/A	Ramp inside XWalk1?	N/A	N/A	Ramp inside XWalk2?	N/A
	Road Slope (%)	8.5		Clear Space?	N/A
	Road X Slope (%)	0.3	N/A	Clear Space to XWalk (in)	N/A
N/A	Any Obstructions?	N/A	N/A	Storm Grate/Utility Hazard?	N/A
	Obstruction Type			Storm Grate/Utility Type	
		N/A			N/A
			Yes	Surface Condition? (G/P)	Good
			No	Curb Slope (%)	8.7

Remove & Replace Curb Ramp With Two New Directional Ramps or Equivalent.
