Access Compliance Report

Public Rights-of-Way

(Curb Ramps)

Intersection ID: 17926	Main Street: N_SHARON_AMITY_RD	Cross Street: RANDOLPH_RD	Location: SW
ADA ID: C13BF2FCC814	Ramp Type: PerpDiag	Initial Pass/Fail: Fail	Overall Compliance: No
Codes/Mitigation Info/Possible Solution		Field Measurements/Component Compliance	
Severity Score: 13.75

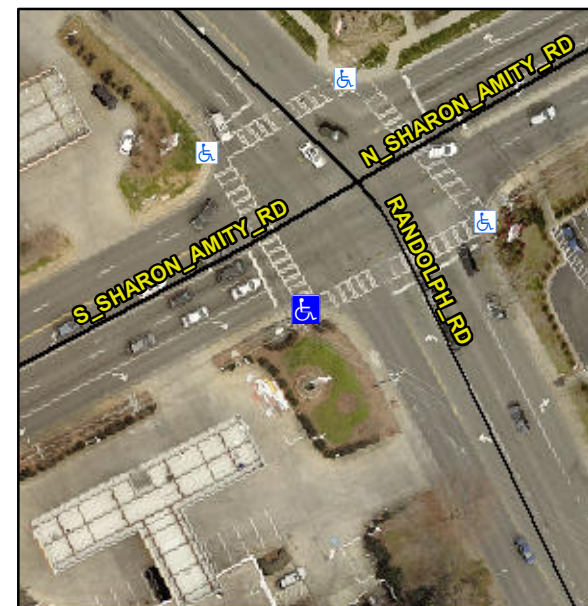
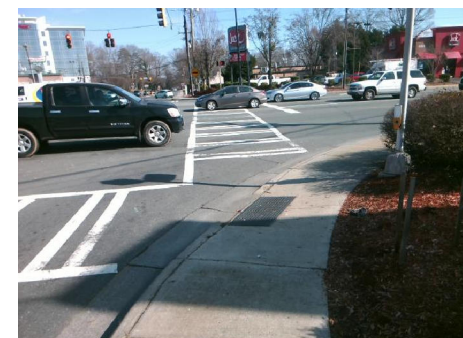
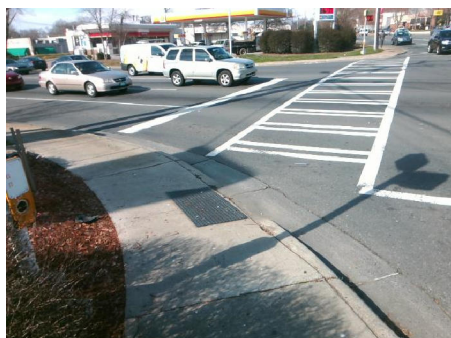
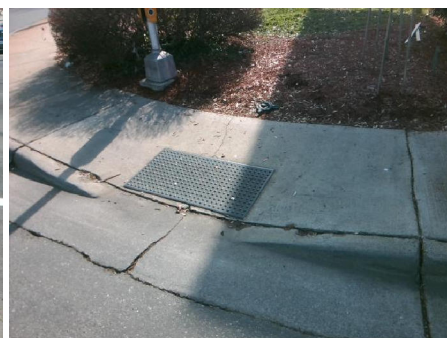
Compliance	Description	Data	Compliance	Description	Data
N/A	Ramp Length (in)	59.0	No	Ramp Slope (%)	11.8
Yes	Ramp Width (in)	48.0	No	Ramp XSlope (%)	3.8
N/A	Flare Type LT	N/A	N/A	Flare Type RT	N/A
N/A	Flare Slope LT (%)	N/A	N/A	Flare Slope RT (%)	N/A
N/A	Flare Traversable LT?	N/A	N/A	Flare Traversable RT?	N/A
N/A	Landing Length (in)	N/A	N/A	DWS Provided?	N/A
N/A	Landing Width (in)	N/A	N/A	DWS Contrast?	N/A
N/A	Landing Slope (%)	N/A	N/A	DWS Length (in)	N/A
N/A	Landing X Slope (%)	N/A	N/A	DWS Full Width?	N/A
N/A	Landing Curb? (Y/N)	N/A	N/A	DWS Offset (in)	N/A
N/A	Shared Landing?	N/A			
N/A	Gutter Ponding?	N/A	N/A	Gutter Slope (%)	N/A
N/A	Gutter Lip Ht (in)	N/A	N/A	Gutter X Slope (%)	N/A
N/A	Painted X Walk1?	Yes	N/A	Painted X Walk2?	Yes
	X Walk 1 Direction	To E		X Walk 2 Direction	To N
N/A	X Walk 1 Width (in)	112.0	N/A	X Walk 2 Width (in)	107.0
	X Walk 1 Slope (%)	7.8		X Walk 2 Slope (%)	3.6
	X Walk 1 X Slope (%)	3.8		X Walk 2 X Slope (%)	4.0

N/A	Ramp inside XWalk1?	Yes	N/A	Ramp inside XWalk2?	Yes
	Road Slope (%)	3.0	N/A	Clear Space?	N/A
	Road X Slope (%)	6.3	N/A	Clear Space to XWalk (in)	N/A
N/A	Any Obstructions?	N/A	N/A	Storm Grate/Utility Hazard?	N/A
	Obstruction Type			Storm Grate/Utility Type	
		N/A			N/A
		Yes		Surface Condition? (G/P)	Good

Possible Solutions:

Remove & Replace Curb Ramp With Two New Directional Ramps or Equivalent.

R304.2.2, R304.5.3

Total Cost: \$ 3200.00
