# Access Compliance Report

## Public Rights-of-Way

### (Curb Ramps)

| Intersection ID: 15394 | Main Street: HERMAN_AV | Cross Street: S_TRYON_ST | Location: N |

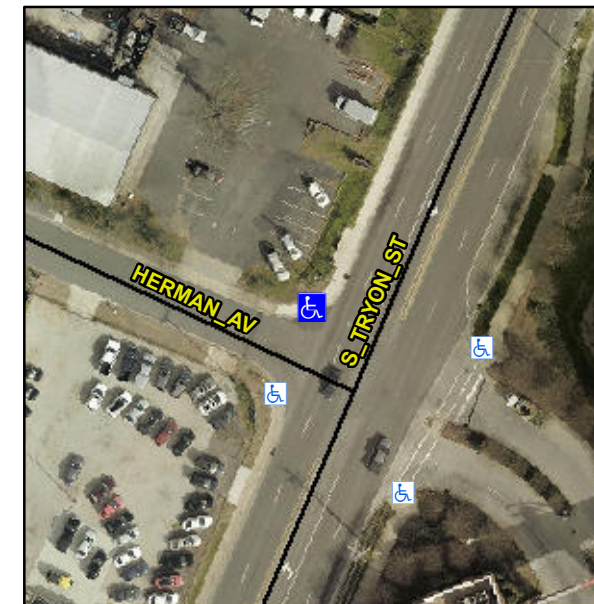
**Not Found, R304.2.2, R304.5.3**

| Compliance | Description | Data | Compliance | Description | Data |
|---|---|---|---|---|---|
| N/A | Ramp Length (in) | 60.0 | No | Ramp Slope (%) | 16.6 |
| Yes | Ramp Width (in) | 48.0 | No | Ramp XSlope (%) | 4.4 |

**Remove & Replace Curb Ramp With Two New Directional Ramps or Equivalent.**
