# Access Compliance Report

## Public Rights-of-Way

### (Curb Ramps)

| Intersection ID: 12063 | Main Street: HAWTHORNE_LN | Cross Street: KENNON_ST | Location: | NE |

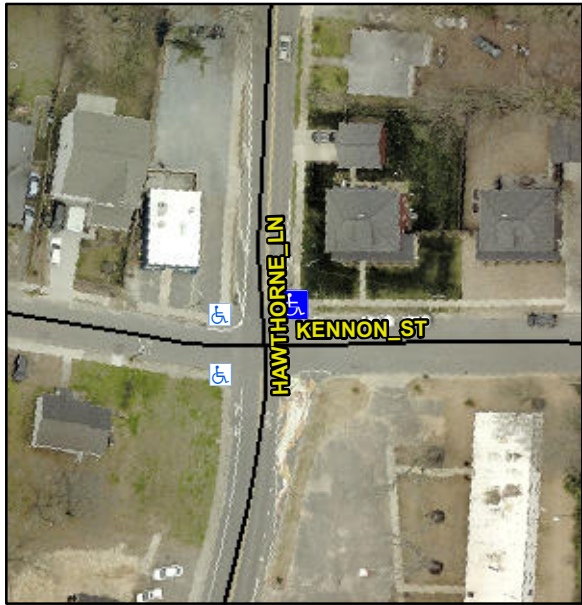
| ADA ID: C148249D144E | Ramp Type: Perp | Initial Pass/Fail: Fail | Overall Compliance: No | Severity Score: 10 |

| | Not Found, R304.5.1, R304.5.3 | | | | | |

| Compliance | Description | Data | Compliance | Description | Data |
|---|---|---|---|---|---|
| No | Ramp Width (in) | 39.0 | No | Ramp XSlope (%) | 4.3 |

| | Remove & Replace Entire Ramp. | | | | | |
