# Access Compliance Report

## Public Rights-of-Way

| Intersection ID: 4075 | Main Street: OVERLOOK_MOUNTAIN_DR | Cross Street: MOUNTAIN_COVE_DR | Location: S |
| ADA ID: C1551118BAFC | Ramp Type: BlendTrans2 | Initial Pass/Fail: Fail | Overall Compliance: No |

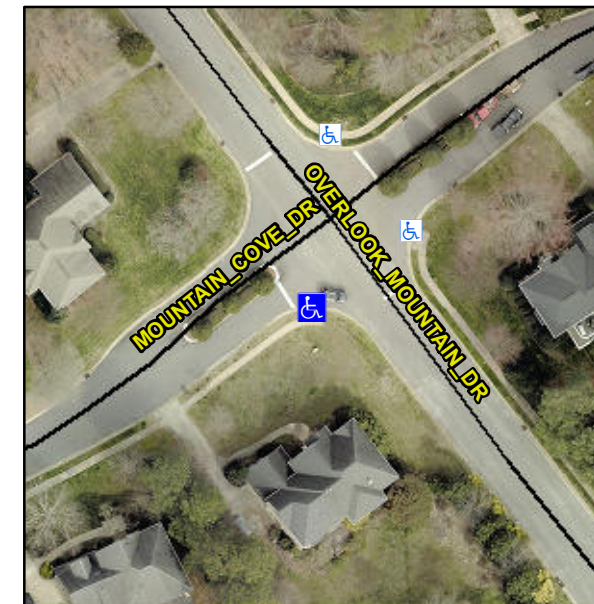
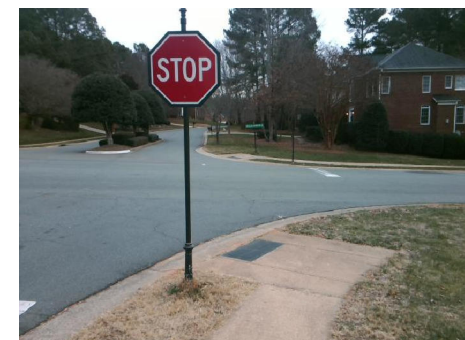
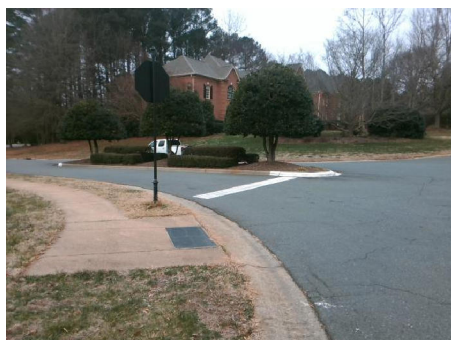
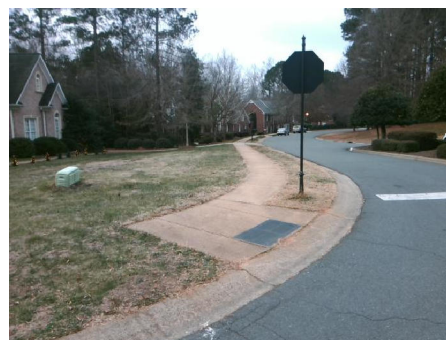
| | | Severity Score: 1.25 | |

**Not Found, R304.5.3**

| Compliance | Description | Data | Compliance | Description | Data |
|---|---|---|---|---|---|
| Yes | Ramp Width (in) | 48.0 | No | BlendTrans XSlope (%) | 2.2 |
| | | | No | Curb Slope (%) | 6.5 |

**Remove & Replace Curb Ramp With Two New Directional Ramps or Equivalent.**

Total Cost: \$ 3200.00
