Access Compliance Report

Public Rights-of-Way

(Curb Ramps)

Intersection ID: 52304	Main Street: IMPATIEN_DR	Cross Street: SNOWBELL_CT	Location: SW
ADA ID: C15CC8DC4DD9	Ramp Type: PerpDiag	Initial Pass/Fail: Fail	Overall Compliance: No
		Severity Score: 10

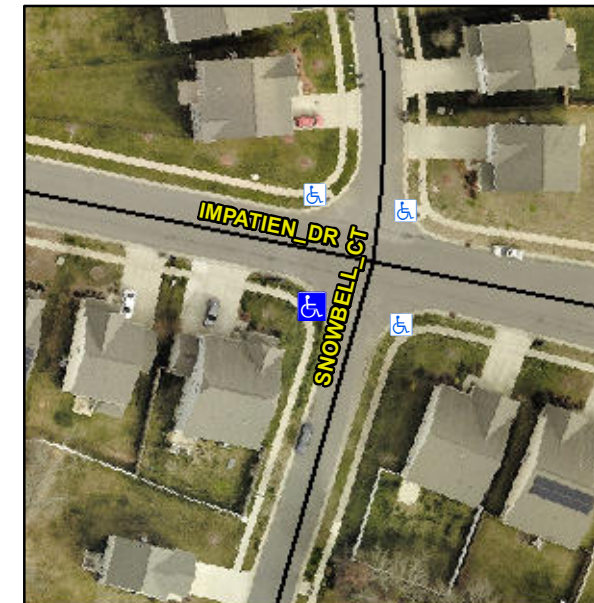
Not Found, R304.5.1, R304.5.3

Compliance	Description	Data	Compliance	Description	Data
N/A	Ramp Length (in)	70.5	Yes	Ramp Slope (%)	5.5
No	Ramp Width (in)	40.5	No	Ramp XSlope (%)	3.2
N/A	Flare Type LT	N/A	N/A	Flare Type RT	N/A
N/A	Flare Slope LT (%)	N/A	N/A	Flare Slope RT (%)	N/A
N/A	Flare Traversable LT?	N/A	N/A	Flare Traversable RT?	N/A
N/A	Landing Length (in)	N/A	N/A	DWS Provided?	N/A
N/A	Landing Width (in)	N/A	N/A	DWS Contrast?	N/A
N/A	Landing Slope (%)	N/A	N/A	DWS Length (in)	N/A
N/A	Landing X Slope (%)	N/A	N/A	DWS Full Width?	N/A
N/A	Landing Curb? (Y/N)	N/A	N/A	DWS Offset (in)	N/A
N/A	Shared Landing?	N/A			
N/A	Gutter Ponding?	N/A	N/A	Gutter Slope (%)	N/A
N/A	Gutter Lip Ht (in)	1.5	N/A	Gutter X Slope (%)	N/A
N/A	Painted X Walk1?	No	N/A	Painted X Walk2?	No
	X Walk 1 Direction	To E		X Walk 2 Direction	To N
N/A	X Walk 1 Width (in)	N/A	N/A	X Walk 2 Width (in)	N/A
	X Walk 1 Slope (%)	2.7		X Walk 2 Slope (%)	4.8
	X Walk 1 X Slope (%)	0.2		X Walk 2 X Slope (%)	3.9

N/A	Ramp inside XWalk1?	N/A	N/A	Ramp inside XWalk2?	N/A
	Road Slope (%)	2.0	N/A	Clear Space?	N/A
	Road X Slope (%)	4.7	N/A	Clear Space to XWalk (in)	N/A
N/A	Any Obstructions?	N/A	N/A	Storm Grate/Utility Hazard?	N/A
	Obstruction Type			Storm Grate/Utility Type	
		N/A			N/A
		Yes		Surface Condition? (G/P)	Good

Remove & Replace Curb Ramp With Two New Directional Ramps or Equivalent.
