## Access Compliance Report Public Rights-of-Way (Curb Ramps)

Intersection ID: 30216	30216 Main Street: HIDDEN_CREEK_DR			Street:	TANSY_DR	Location:	W		
ADA ID: C15CDA9885BA	Ramp Ty	Ramp Type: PerpDiag			nitial Pass/Fail: Fail Overall Compliance: No				22.5
Codes/Mitigation Info/Possible Solution				Field Measurements/Component Compliance					
	The second second	Possible Solutions:		Compliance Description			Data Compliance Description		Data
		Remove & Replace Curb Ramp	With	N/A	Ramp Length (in)	47.5		Ramp Slope (%)	9.1
		Two New Directional Ramps or		No	Ramp Width (in)	39.5	No	Ramp XSlope (%)	2.9
		Equivalent.		N/A	Flare Type LT	N/A	N/A	Flare Type RT	N/A
				N/A	Flare Slope LT (%)	N/A	N/A	Flare Slope RT (%)	N/A
4100	W/A			N/A	Flare Traversable LT?	N/A	N/A	Flare Traversable RT?	N/A
	MAX AM	Surveyor Notes:		N/A	Landing Length (in)	N/A		DWS Provided?	N/A
	2 8 6 - 1			N/A	Landing Width (in)	N/A	N/A	DWS Contrast?	N/A
E C		N/A		N/A	Landing Slope (%)	N/A		DWS Length (in)	N/A

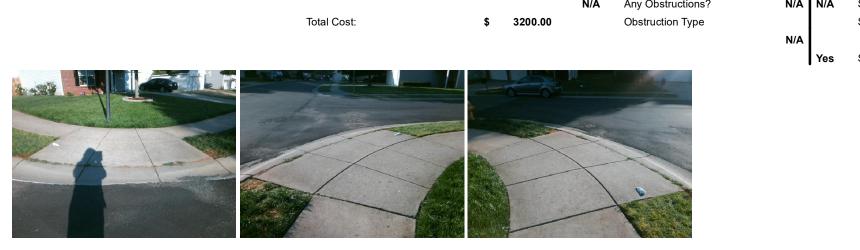
10/6		N/A	Landing X Slope (%)	N/A	N/A	DWS Full Width?	N/A
	G.			N/A	Landing Curb? (Y/N)	N/A	N/A	DWS Offset (in)	N/A
	1/AL			N/A	Shared Landing?	N/A		2110 011001 (11)	
State of the second sec	N.A. M.	PROW/ADA:		N/A	Gutter Ponding?	N/A	N/A	Gutter Slope (%)	N/A
	V Anno - \	Not Found, R304.5.1, R304.2.2, R304.5.3		N/A	Gutter Lip Ht (in)	N/A	N/A	Gutter X Slope (%)	N/A
	AFT A			N/A	Painted X Walk1?	No	N/A	Painted X Walk2?	No
		1004.0.0		11/14	X Walk 1 Direction	To SE		X Walk 2 Direction	To NE
a la series a series	e and			N/A	X Walk 1 Width (in)	N/A	N/A	X Walk 2 Width (in)	N/A
Street 1 Name TANSY DR			N/A	X Walk 1 Slope (%)	0.4	N/A	X Walk 2 Slope (%)	0.7	
Stop Condition-Street 2	StopSign				X Walk 1 X Slope (%)	0.4 1.9		X Walk 2 X Slope (%)	0.7 1.7
Street 2 Name	HIDDEN CREEK DR			N/A	Ramp inside XWalk1?	N/A	N/A	Ramp inside XWalk2?	N/A
Stop Condition-Street 1	None			N/A	Road Slope (%)	N/A 1.7	N/A	Clear Space?	N/A N/A

Stop Condition-Street 1	None				• • • •			•	
				NI/A	Road X Slope (%)	0.4	N/A	Clear Space to XWalk (in)	N/A
		Tatal Cast		N/A	Any Obstructions?	N/A	N/A	Storm Grate/Utility Hazard?	N/A
		Total Cost: \$	3200.00		Obstruction Type			Storm Grate/Utility Type	
						N/A			N/A
