Access Compliance Report

Public Rights-of-Way

(Curb Ramps)

Intersection ID: 5600	Main Street: N_TRYON_ST	Cross Street: J_M_KEYNES_DR	Location: W
ADA ID: C165C76CDFB8	Ramp Type: Perp	Initial Pass/Fail: Pass	Overall Compliance: No
		Severity Score: 20

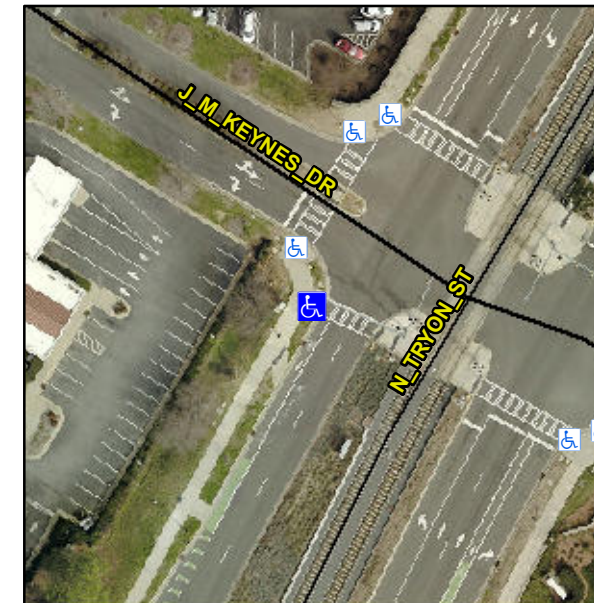
Compliance	Description	Data	Compliance	Description	Data
N/A	Ramp Length (in)	71.0	Yes	Ramp Slope (%)	7.4
Yes	Ramp Width (in)	48.0	Yes	Ramp XSlope (%)	2.0
N/A	Flare Type LT	Sloped	N/A	Flare Type RT	N/A
N/A	Flare Slope LT (%)	6.9	Yes	Flare Slope RT (%)	9.6
N/A	Flare Traversable LT?	Yes	N/A	Flare Traversable RT?	Yes
Yes	Landing Length (in)	126.0	Yes	DWS Provided?	Yes
Yes	Landing Width (in)	48.0	Yes	DWS Contrast?	Yes
Yes	Landing Slope (%)	0.6	Yes	DWS Length (in)	24.0
Yes	Landing X Slope (%)	1.0	Yes	DWS Full Width?	Yes
N/A	Landing Curb? (Y/N)	Yes	Yes	DWS Offset (in)	0.0
N/A	Shared Landing?	No			
No	Gutter Ponding?	Yes	No	Gutter Slope (%)	8.1
No	Gutter Lip Ht (in)	1.0	Yes	Gutter X Slope (%)	1.2
N/A	Painted X Walk1?	No	N/A	Painted X Walk2?	N/A
	X Walk 1 Direction	To SE		X Walk 2 Direction	N/A
N/A	X Walk 1 Width (in)	N/A	N/A	X Walk 2 Width (in)	N/A
	X Walk 1 Slope (%)	0.2		X Walk 2 Slope (%)	N/A
	X Walk 1 X Slope (%)	1.5		X Walk 2 X Slope (%)	N/A

N/A	Ramp inside XWalk1?	N/A	N/A	Ramp inside XWalk2?	N/A
	Road Slope (%)	N/A	N/A	Clear Space?	Yes
	Road X Slope (%)	N/A	N/A	Clear Space to XWalk (in)	N/A
Yes	Any Obstructions?	No	Yes	Storm Grate/Utility Hazard?	No
	Obstruction Type			Storm Grate/Utility Type	
		N/A			N/A
			Yes	Surface Condition? (G/P)	Good

Remove & Replace Gutter.

R302.7, R302.7.2, R304.5.4

Total Cost: \$ 750.00
