Access Compliance Report

Public Rights-of-Way

(Curb Ramps)

Intersection ID: 28656	Main Street: CAVETT_CT	Cross Street: HAMPTON_PLACE_DR	Location: SE
ADA ID: C1757EAE5DE0	Ramp Type: Perp	Initial Pass/Fail: Fail	Overall Compliance: No
Severity Score: 12.5			
Codes/Mitigation Info/Possible Solution		Field Measurements/Component Compliance

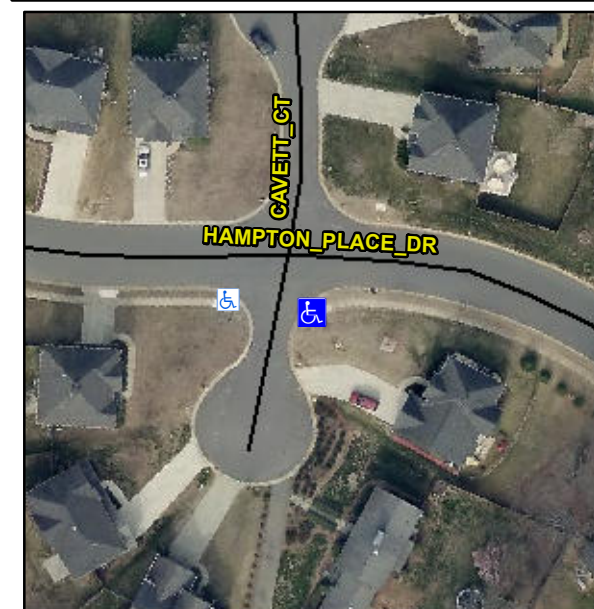
Not Found, R304.2.2

Compliance	Description	Data	Compliance	Description	Data
N/A	Ramp Length (in)	48.0	No	Ramp Slope (%)	8.5
Yes	Ramp Width (in)	48.0	Yes	Ramp XSlope (%)	0.3
N/A	Flare Type LT	N/A	N/A	Flare Type RT	N/A
N/A	Flare Slope LT (%)	N/A	N/A	Flare Slope RT (%)	N/A
N/A	Flare Traversable LT?	N/A	N/A	Flare Traversable RT?	N/A
N/A	Landing Length (in)	N/A	N/A	DWS Provided?	N/A
N/A	Landing Width (in)	N/A	N/A	DWS Contrast?	N/A
N/A	Landing Slope (%)	N/A	N/A	DWS Length (in)	N/A
N/A	Landing X Slope (%)	N/A	N/A	DWS Full Width?	N/A
N/A	Landing Curb? (Y/N)	N/A	N/A	DWS Offset (in)	N/A
N/A	Shared Landing?	N/A			
N/A	Gutter Ponding?	N/A	N/A	Gutter Slope (%)	N/A
N/A	Gutter Lip Ht (in)	N/A	N/A	Gutter X Slope (%)	N/A
N/A	Painted X Walk1?	No	N/A	Painted X Walk2?	N/A
	X Walk 1 Direction	To W		X Walk 2 Direction	N/A
N/A	X Walk 1 Width (in)	N/A	N/A	X Walk 2 Width (in)	N/A
	X Walk 1 Slope (%)	3.1		X Walk 2 Slope (%)	N/A
	X Walk 1 X Slope (%)	2.1		X Walk 2 X Slope (%)	N/A

N/A	Ramp inside XWalk1?	N/A	N/A	Ramp inside XWalk2?	N/A
	Road Slope (%)	N/A	N/A	Clear Space?	N/A
	Road X Slope (%)	N/A	N/A	Clear Space to XWalk (in)	N/A
N/A	Any Obstructions?	N/A	N/A	Storm Grate/Utility Hazard?	N/A
	Obstruction Type			Storm Grate/Utility Type	
		N/A			N/A
			Yes	Surface Condition? (G/P)	Good

Possible Solutions:

Remove & Replace Entire Ramp.
