# Access Compliance Report

## Public Rights-of-Way

### (Curb Ramps)

Intersection ID: 10030	Main Street: E_28TH_ST	Cross Street: N_TRYON_ST	Location: SE
ADA ID: C177E675ED1F	Ramp Type: PerpDiag	Initial Pass/Fail: Fail	Overall Compliance: No
Severity Score: 48.75			
Codes/Mitigation Info/Possible Solution		Field Measurements/Component Compliance

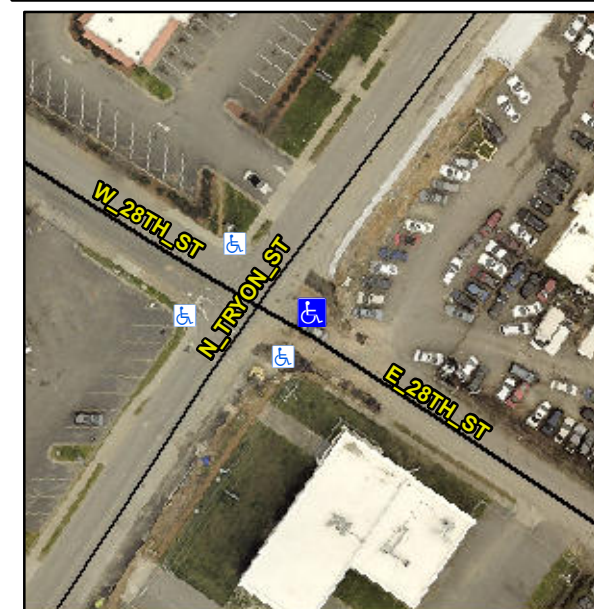
**Not Found, R304.5.1, R304.5.3, R302.7**

Compliance	Description	Data	Compliance	Description	Data
N/A	Ramp Length (in)	59.5	Yes	Ramp Slope (%)	6.0
No	Ramp Width (in)	36.0	No	Ramp XSlope (%)	7.8
N/A	Flare Type LT	N/A	N/A	Flare Type RT	N/A
N/A	Flare Slope LT (%)	N/A	N/A	Flare Slope RT (%)	N/A
N/A	Flare Traversable LT?	N/A	N/A	Flare Traversable RT?	N/A
N/A	Landing Length (in)	N/A	N/A	DWS Provided?	N/A
N/A	Landing Width (in)	N/A	N/A	DWS Contrast?	N/A
N/A	Landing Slope (%)	N/A	N/A	DWS Length (in)	N/A
N/A	Landing X Slope (%)	N/A	N/A	DWS Full Width?	N/A
N/A	Landing Curb? (Y/N)	N/A	N/A	DWS Offset (in)	N/A
N/A	Shared Landing?	N/A			
N/A	Gutter Ponding?	N/A	N/A	Gutter Slope (%)	N/A
N/A	Gutter Lip Ht (in)	3.0	N/A	Gutter X Slope (%)	N/A
N/A	Painted X Walk1?	Yes	N/A	Painted X Walk2?	No
	X Walk 1 Direction	To NW		X Walk 2 Direction	To SW
N/A	X Walk 1 Width (in)	122.0	N/A	X Walk 2 Width (in)	N/A
	X Walk 1 Slope (%)	1.9		X Walk 2 Slope (%)	5.2
	X Walk 1 X Slope (%)	4.9		X Walk 2 X Slope (%)	1.0

N/A	Ramp inside XWalk1?	Yes	N/A	Ramp inside XWalk2?	N/A
	Road Slope (%)	3.7	N/A	Clear Space?	N/A
	Road X Slope (%)	3.7	N/A	Clear Space to XWalk (in)	N/A
N/A	Any Obstructions?	N/A	N/A	Storm Grate/Utility Hazard?	N/A
	Obstruction Type			Storm Grate/Utility Type	
		N/A			N/A
		No		Surface Condition? (G/P)	Poor

**Remove & Replace Curb Ramp With Two New Directional Ramps or Equivalent.**

Total Cost: \$ 3200.00
