# Access Compliance Report

## Public Rights-of-Way

### (Curb Ramps)

Intersection ID: 23822	Main Street: RANDWICKE_PL	Cross Street: REA_RD	Location:	N
ADA ID: C17A9A3DDCD6	Ramp Type: Directional1	Initial Pass/Fail: Fail	Overall Compliance: No	Severity Score: 12.5
Codes/Mitigation Info/Possible Solution		Field Measurements/Component Compliance

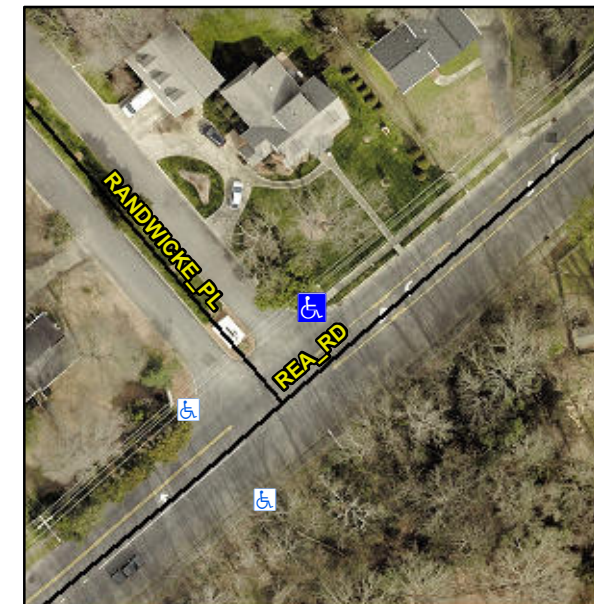
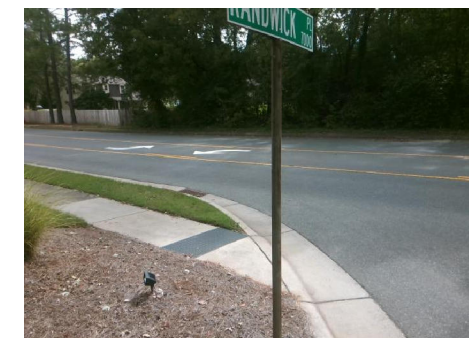
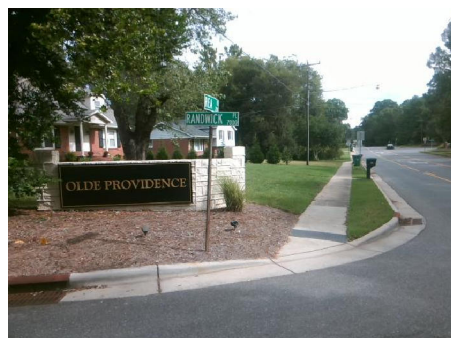
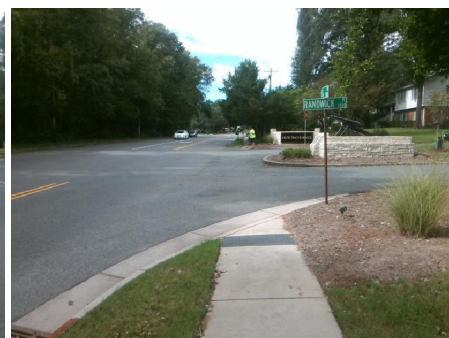
Compliance	Description	Data	Compliance	Description	Data
N/A	Ramp Length (in)	92.0	N/A	Grade Break?	N/A
Yes	Ramp Width (in)	48.0	N/A	Grade Break Slope (%)	0.0
Yes	Ramp Slope (%)	0.2	N/A	Grade Break XSlope (%)	0.0
No	Ramp XSlope (%)	6.4			
N/A	Flare Type LT	N/A	N/A	Flare Type RT	N/A
N/A	Flare Slope LT (%)	N/A	N/A	Flare Slope RT (%)	0.0
N/A	Flare Traversable LT?	N/A	N/A	Flare Traversable RT?	N/A
N/A	Landing Length (in)	0.0	N/A	DWS Provided?	N/A
N/A	Landing Width (in)	0.0	N/A	DWS Contrast?	N/A
N/A	Landing Slope (%)	0.0	N/A	DWS Length (in)	N/A
N/A	Landing X Slope (%)	0.0	N/A	DWS Full Width?	N/A
N/A	Landing Curb? (Y/N)	N/A	N/A	DWS Offset LT (in)	N/A
N/A	Shared Landing?	N/A	N/A	DWS Offset RT (in)	N/A
N/A	Gutter Ponding?	0.0	N/A	Gutter Slope (%)	N/A
N/A	Gutter Lip Ht (in)	0.0	N/A	Gutter X Slope (%)	N/A
N/A	Painted X Walk1?	No		Road Slope (%)	4.5
	X Walk 1 Direction	To SW		Road X Slope (%)	1.6
	X Walk 1 Width (in)	N/A		Clear Space?	N/A

X Walk 1 Slope (%)	4.5	N/A	Clear Space to XWalk (in)	N/A
	X Walk 1 X Slope (%)	1.6	N/A	Storm Grate/Utility Hazard?	N/A
N/A	Ramp inside XWalk1?	N/A		Storm Grate/Utility Type	
N/A	Any Obstructions?	N/A			N/A
	Obstruction Type		Yes	Surface Condition? (G/P)	Good
			N/A	Curb Slope (%)	7.3

**Remove & Replace Entire Ramp.**

Total Cost: \$ 1600.00
