Access Compliance Report

Public Rights-of-Way

(Curb Ramps)

Intersection ID: 5741	Main Street: MALLARD_CREEK_RD	Cross Street: NEVIN_RD	Location: S
ADA ID: C188C04EDFC9	Ramp Type: MedianPerp	Initial Pass/Fail: Fail	Overall Compliance: No
Severity Score: 12.5			
Codes/Mitigation Info/Possible Solution		Field Measurements/Component Compliance

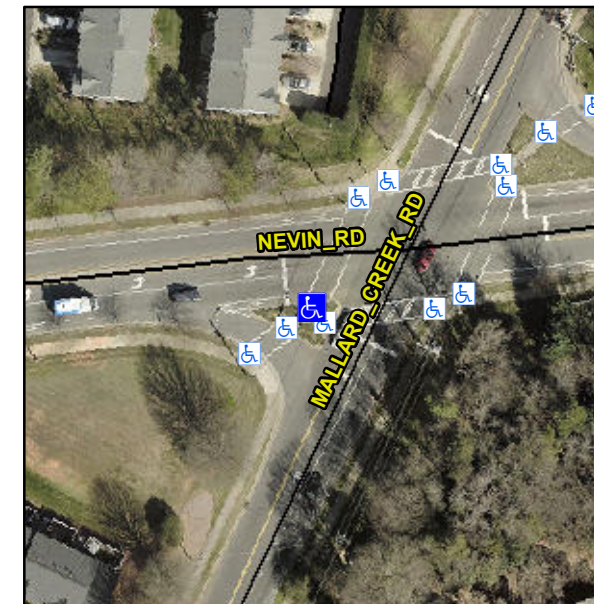
Not Found, R304.2.2

Compliance	Description	Data	Compliance	Description	Data
N/A	Ramp Length (in)	36.0	No	Ramp Slope (%)	8.4
Yes	Ramp Width (in)	80.0	Yes	Ramp XSlope (%)	2.0
N/A	Flare Type LT	N/A	N/A	Flare Type RT	N/A
N/A	Flare Slope LT (%)	N/A	N/A	Flare Slope RT (%)	N/A
N/A	Flare Traversable LT?	N/A	N/A	Flare Traversable RT?	N/A
N/A	Landing Length (in)	N/A	N/A	DWS Provided?	N/A
N/A	Landing Width (in)	N/A	N/A	DWS Contrast?	N/A
N/A	Landing Slope (%)	N/A	N/A	DWS Length (in)	N/A
N/A	Landing X Slope (%)	N/A	N/A	DWS Full Width?	N/A
N/A	Landing Curb? (Y/N)	N/A	N/A	DWS Offset (in)	N/A
N/A	Shared Landing?	N/A			
N/A	Gutter Ponding?	N/A	N/A	Gutter Slope (%)	N/A
N/A	Gutter Lip Ht (in)	N/A	N/A	Gutter X Slope (%)	N/A
N/A	Painted X Walk1?	Yes	N/A	Painted X Walk2?	N/A
	X Walk 1 Direction	To NE		X Walk 2 Direction	N/A
N/A	X Walk 1 Width (in)	139.0	N/A	X Walk 2 Width (in)	N/A
	X Walk 1 Slope (%)	0.7		X Walk 2 Slope (%)	N/A
	X Walk 1 X Slope (%)	1.3		X Walk 2 X Slope (%)	N/A

N/A	Ramp inside XWalk1?	Yes	N/A	Ramp inside XWalk2?	N/A
	Road Slope (%)	N/A	N/A	Clear Space?	N/A
	Road X Slope (%)	N/A	N/A	Clear Space to XWalk (in)	N/A
N/A	Any Obstructions?	N/A	N/A	Storm Grate/Utility Hazard?	N/A
	Obstruction Type			Storm Grate/Utility Type	
		N/A			N/A
			Yes	Surface Condition? (G/P)	Good

Remove & Replace Entire Ramp.
