Access Compliance Report

Public Rights-of-Way

(Curb Ramps)

Intersection ID: 23117	Main Street: CEDAR_CROSSINGS_DR	Cross Street: ERWIN_RD	Location: SE
ADA ID: C19789630EB4	Ramp Type: PerpDiag	Initial Pass/Fail: Fail	Overall Compliance: No
Severity Score: 35			
Codes/Mitigation Info/Possible Solution		Field Measurements/Component Compliance

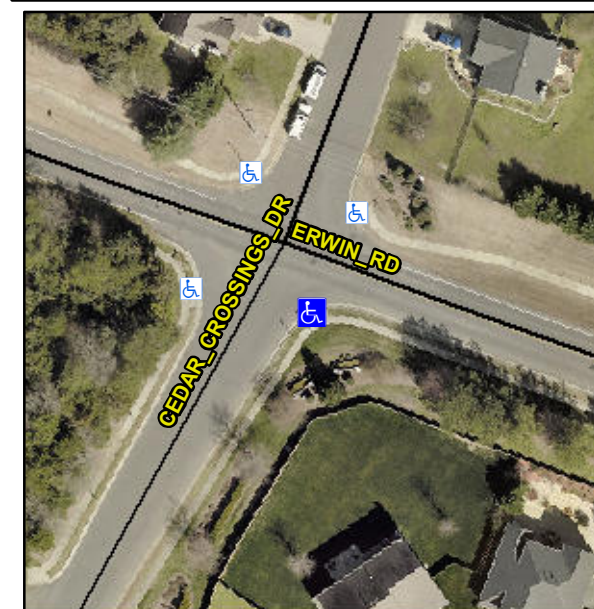
Compliance	Description	Data	Compliance	Description	Data
N/A	Ramp Length (in)	47.0	No	Ramp Slope (%)	12.3
No	Ramp Width (in)	42.0	No	Ramp XSlope (%)	4.5
N/A	Flare Type LT	N/A	N/A	Flare Type RT	N/A
N/A	Flare Slope LT (%)	N/A	N/A	Flare Slope RT (%)	N/A
N/A	Flare Traversable LT?	N/A	N/A	Flare Traversable RT?	N/A
N/A	Landing Length (in)	N/A	N/A	DWS Provided?	N/A
N/A	Landing Width (in)	N/A	N/A	DWS Contrast?	N/A
N/A	Landing Slope (%)	N/A	N/A	DWS Length (in)	N/A
N/A	Landing X Slope (%)	N/A	N/A	DWS Full Width?	N/A
N/A	Landing Curb? (Y/N)	N/A	N/A	DWS Offset (in)	N/A
N/A	Shared Landing?	N/A			
N/A	Gutter Ponding?	N/A	N/A	Gutter Slope (%)	N/A
N/A	Gutter Lip Ht (in)	N/A	N/A	Gutter X Slope (%)	N/A
N/A	Painted X Walk1?	No	N/A	Painted X Walk2?	No
	X Walk 1 Direction	To NE		X Walk 2 Direction	To NW
N/A	X Walk 1 Width (in)	N/A	N/A	X Walk 2 Width (in)	N/A
	X Walk 1 Slope (%)	5.4		X Walk 2 Slope (%)	0.9
	X Walk 1 X Slope (%)	0.4		X Walk 2 X Slope (%)	4.6

N/A	Ramp inside XWalk1?	N/A	N/A	Ramp inside XWalk2?	N/A
	Road Slope (%)	3.8	N/A	Clear Space?	N/A
	Road X Slope (%)	4.9	N/A	Clear Space to XWalk (in)	N/A
N/A	Any Obstructions?	N/A	N/A	Storm Grate/Utility Hazard?	N/A
	Obstruction Type			Storm Grate/Utility Type	
		N/A			N/A
			Yes	Surface Condition? (G/P)	Good

Possible Solutions:

Remove & Replace Curb Ramp With Two New Directional Ramps or Equivalent.

R304.5.1, R304.2.2, R304.5.3
