Access Compliance Report

Public Rights-of-Way (Curb Ramps)

Intersection ID: 43116	Main Street: CENTRAL_AV	Cross Street: PECAN_AV	Location: SW
ADA ID: C19B0BC73F66	Ramp Type: Perp	Initial Pass/Fail: Fail	Overall Compliance: No Severity Score: 21.25

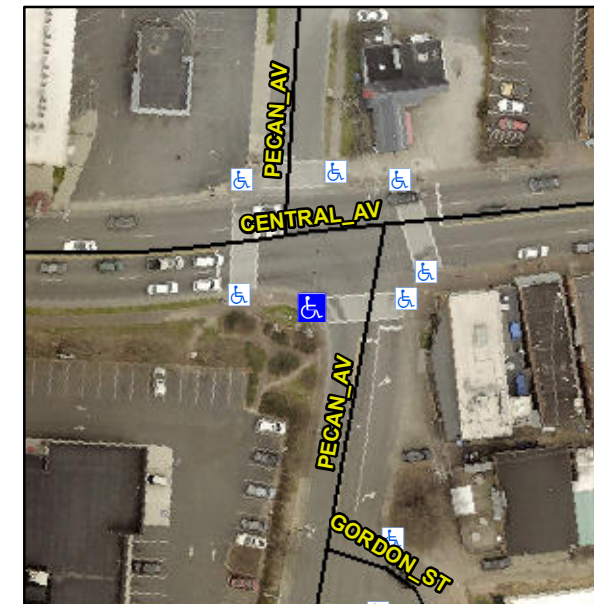
Not Found, R304.5.1, R304.2.2

Compliance	Description	Data	Compliance	Description	Data
N/A	Ramp Length (in)	66.0	No	Ramp Slope (%)	8.4
No	Ramp Width (in)	46.0	Yes	Ramp XSlope (%)	1.7
N/A	Flare Type LT	N/A	N/A	Flare Type RT	N/A
N/A	Flare Slope LT (%)	N/A	N/A	Flare Slope RT (%)	N/A
N/A	Flare Traversable LT?	N/A	N/A	Flare Traversable RT?	N/A
N/A	Landing Length (in)	N/A	N/A	DWS Provided?	N/A
N/A	Landing Width (in)	N/A	N/A	DWS Contrast?	N/A
N/A	Landing Slope (%)	N/A	N/A	DWS Length (in)	N/A
N/A	Landing X Slope (%)	N/A	N/A	DWS Full Width?	N/A
N/A	Landing Curb? (Y/N)	N/A	N/A	DWS Offset (in)	N/A
N/A	Shared Landing?	N/A			
N/A	Gutter Ponding?	N/A	N/A	Gutter Slope (%)	N/A
N/A	Gutter Lip Ht (in)	N/A	N/A	Gutter X Slope (%)	N/A
N/A	Painted X Walk1?	Yes	N/A	Painted X Walk2?	N/A
	X Walk 1 Direction	To E		X Walk 2 Direction	N/A
N/A	X Walk 1 Width (in)	144.0	N/A	X Walk 2 Width (in)	N/A
	X Walk 1 Slope (%)	4.4		X Walk 2 Slope (%)	N/A
	X Walk 1 X Slope (%)	3.4		X Walk 2 X Slope (%)	N/A

N/A	Ramp inside XWalk1?	Yes	N/A	Ramp inside XWalk2?	N/A
	Road Slope (%)	N/A	N/A	Clear Space?	N/A
	Road X Slope (%)	N/A	N/A	Clear Space to XWalk (in)	N/A
N/A	Any Obstructions?	N/A	N/A	Storm Grate/Utility Hazard?	N/A
	Obstruction Type			Storm Grate/Utility Type	
		N/A			N/A
		Yes		Surface Condition? (G/P)	Good

Remove & Replace Entire Ramp.

Total Cost: \$ 1850.00
