Access Compliance Report

Public Rights-of-Way

(Curb Ramps)

Intersection ID: 10015045	Main Street: CARLEEN_WAY_DR	Cross Street: N/A	Location: S
ADA ID: C19B60926577	Ramp Type: PerpDiag	Initial Pass/Fail: Fail	Overall Compliance: No
		Severity Score: 47.5	
Codes/Mitigation Info/Possible Solution		Field Measurements/Component Compliance

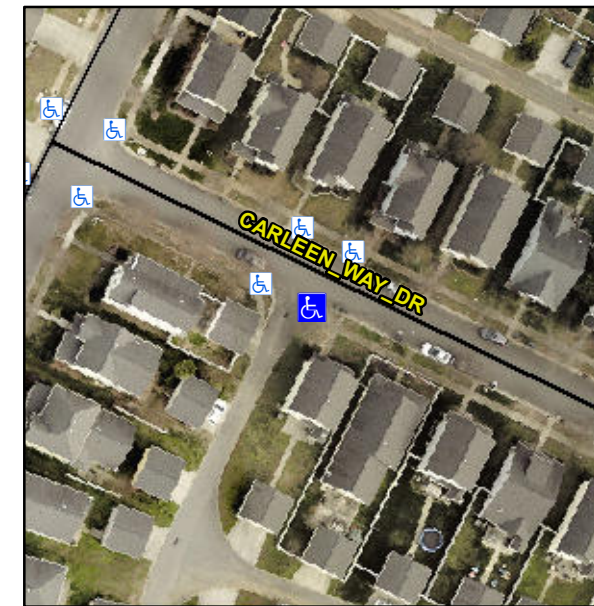
Not Found, R304.5.1, R304.5.3

Compliance	Description	Data	Compliance	Description	Data
N/A	Ramp Length (in)	57.5	Yes	Ramp Slope (%)	5.2
No	Ramp Width (in)	21.0	No	Ramp XSlope (%)	5.3
N/A	Flare Type LT	N/A	N/A	Flare Type RT	N/A
N/A	Flare Slope LT (%)	N/A	N/A	Flare Slope RT (%)	N/A
N/A	Flare Traversable LT?	N/A	N/A	Flare Traversable RT?	N/A
N/A	Landing Length (in)	N/A	N/A	DWS Provided?	N/A
N/A	Landing Width (in)	N/A	N/A	DWS Contrast?	N/A
N/A	Landing Slope (%)	N/A	N/A	DWS Length (in)	N/A
N/A	Landing X Slope (%)	N/A	N/A	DWS Full Width?	N/A
N/A	Landing Curb? (Y/N)	N/A	N/A	DWS Offset (in)	N/A
N/A	Shared Landing?	N/A			
N/A	Gutter Ponding?	N/A	N/A	Gutter Slope (%)	N/A
N/A	Gutter Lip Ht (in)	N/A	N/A	Gutter X Slope (%)	N/A
N/A	Painted X Walk1?	No	N/A	Painted X Walk2?	No
	X Walk 1 Direction	To E		X Walk 2 Direction	To W
N/A	X Walk 1 Width (in)	N/A	N/A	X Walk 2 Width (in)	N/A
	X Walk 1 Slope (%)	0.6		X Walk 2 Slope (%)	2.8
	X Walk 1 X Slope (%)	4.5		X Walk 2 X Slope (%)	0.2

N/A	Ramp inside XWalk1?	N/A	N/A	Ramp inside XWalk2?	N/A
	Road Slope (%)	2.5	N/A	Clear Space?	N/A
	Road X Slope (%)	2.9	N/A	Clear Space to XWalk (in)	N/A
N/A	Any Obstructions?	N/A	N/A	Storm Grate/Utility Hazard?	N/A
	Obstruction Type			Storm Grate/Utility Type	
		N/A			N/A
			Yes	Surface Condition? (G/P)	Good

Remove & Replace Curb Ramp With Two New Directional Ramps or Equivalent.
