# Access Compliance Report

## Public Rights-of-Way

### (Curb Ramps)

Intersection ID: 10034401	Main Street: PIEDMONT_PARK_DR	Cross Street: SAGE_PARK_DR	Location: W
ADA ID: C1A59CCCE313	Ramp Type: Directional1	Initial Pass/Fail: Fail	Overall Compliance: No
Severity Score: 12.5			
Codes/Mitigation Info/Possible Solution		Field Measurements/Component Compliance

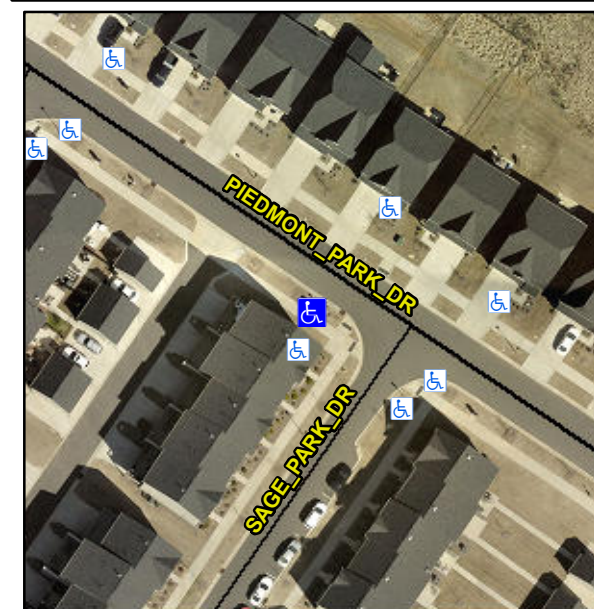
Compliance	Description	Data	Compliance	Description	Data
N/A	Ramp Length (in)	62.0	N/A	Grade Break?	N/A
Yes	Ramp Width (in)	71.0	N/A	Grade Break Slope (%)	0.0
No	Ramp Slope (%)	10.2	N/A	Grade Break XSlope (%)	0.0
Yes	Ramp XSlope (%)	1.1			
N/A	Flare Type LT	N/A	N/A	Flare Type RT	N/A
N/A	Flare Slope LT (%)	N/A	N/A	Flare Slope RT (%)	0.0
N/A	Flare Traversable LT?	N/A	N/A	Flare Traversable RT?	N/A
N/A	Landing Length (in)	0.0	N/A	DWS Provided?	N/A
N/A	Landing Width (in)	0.0	N/A	DWS Contrast?	N/A
N/A	Landing Slope (%)	0.0	N/A	DWS Length (in)	N/A
N/A	Landing X Slope (%)	0.0	N/A	DWS Full Width?	N/A
N/A	Landing Curb? (Y/N)	N/A	N/A	DWS Offset LT (in)	N/A
N/A	Shared Landing?	N/A	N/A	DWS Offset RT (in)	N/A
N/A	Gutter Ponding?	0.0	N/A	Gutter Slope (%)	N/A
N/A	Gutter Lip Ht (in)	0.0	N/A	Gutter X Slope (%)	N/A
N/A	Painted X Walk1?	No		Road Slope (%)	1.7
	X Walk 1 Direction	To NE		Road X Slope (%)	0.0
	X Walk 1 Width (in)	N/A		Clear Space?	N/A

X Walk 1 Slope (%)	1.7	N/A	Clear Space to XWalk (in)	N/A
	X Walk 1 X Slope (%)	0.0	N/A	Storm Grate/Utility Hazard?	N/A
N/A	Ramp inside XWalk1?	N/A		Storm Grate/Utility Type	
N/A	Any Obstructions?	N/A			N/A
	Obstruction Type		Yes	Surface Condition? (G/P)	Good
			N/A	Curb Slope (%)	5.0

**Remove & Replace Entire Ramp.**

**R304.2.2**

\$ 1600.00
