# Access Compliance Report

## Public Rights-of-Way

### (Curb Ramps)

Intersection ID: 17032	Main Street: QUEENS_RD_WEST	Cross Street: WESTFIELD_RD	Location: SE
ADA ID: C1A8CF8772C2	Ramp Type: Perp	Initial Pass/Fail: Fail	Overall Compliance: No
Severity Score: 26.25			
Codes/Mitigation Info/Possible Solution		Field Measurements/Component Compliance

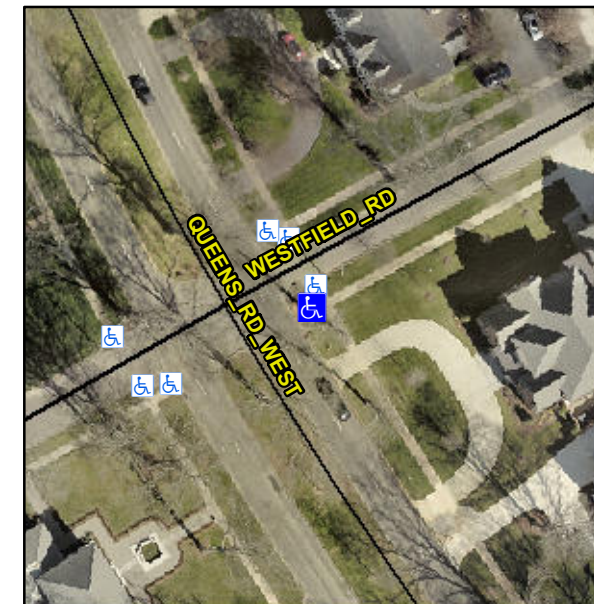
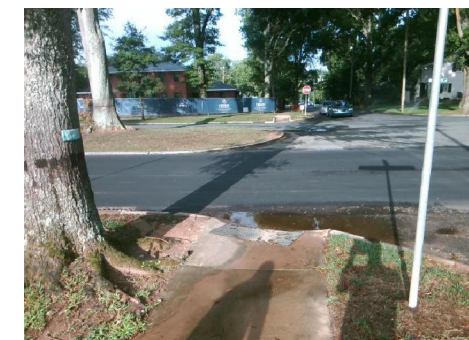
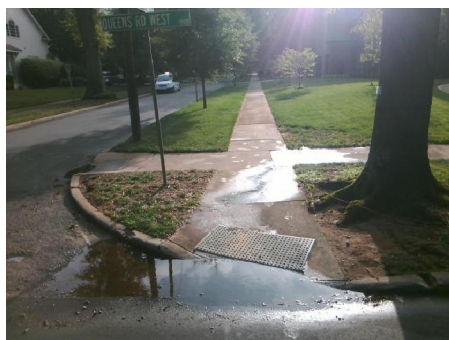
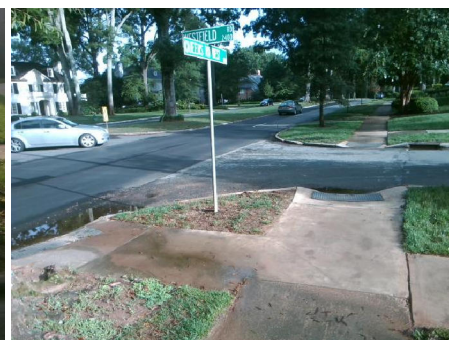
Compliance	Description	Data	Compliance	Description	Data
N/A	Ramp Length (in)	53.0	No	Ramp Slope (%)	12.5
Yes	Ramp Width (in)	65.0	No	Ramp XSlope (%)	3.7
N/A	Flare Type LT	N/A	N/A	Flare Type RT	N/A
N/A	Flare Slope LT (%)	N/A	N/A	Flare Slope RT (%)	N/A
N/A	Flare Traversable LT?	N/A	N/A	Flare Traversable RT?	N/A
N/A	Landing Length (in)	N/A	N/A	DWS Provided?	N/A
N/A	Landing Width (in)	N/A	N/A	DWS Contrast?	N/A
N/A	Landing Slope (%)	N/A	N/A	DWS Length (in)	N/A
N/A	Landing X Slope (%)	N/A	N/A	DWS Full Width?	N/A
N/A	Landing Curb? (Y/N)	N/A	N/A	DWS Offset (in)	N/A
N/A	Shared Landing?	N/A			
N/A	Gutter Ponding?	N/A	N/A	Gutter Slope (%)	N/A
N/A	Gutter Lip Ht (in)	N/A	N/A	Gutter X Slope (%)	N/A
N/A	Painted X Walk1?	No	N/A	Painted X Walk2?	N/A
	X Walk 1 Direction	To SW		X Walk 2 Direction	N/A
N/A	X Walk 1 Width (in)	N/A	N/A	X Walk 2 Width (in)	N/A
	X Walk 1 Slope (%)	3.5		X Walk 2 Slope (%)	N/A
	X Walk 1 X Slope (%)	0.5		X Walk 2 X Slope (%)	N/A

N/A	Ramp inside XWalk1?	N/A	N/A	Ramp inside XWalk2?	N/A
	Road Slope (%)	N/A	N/A	Clear Space?	N/A
	Road X Slope (%)	N/A	N/A	Clear Space to XWalk (in)	N/A
N/A	Any Obstructions?	N/A	N/A	Storm Grate/Utility Hazard?	N/A
	Obstruction Type			Storm Grate/Utility Type	
		N/A			N/A
			Yes	Surface Condition? (G/P)	Good

**Remove & Replace Entire Ramp.**

**R304.2.2, R304.5.3**

**\$ 1850.00**
