Access Compliance Report

Public Rights-of-Way

(Curb Ramps)

Intersection ID: N/A	Main Street: STATESVILLE_AV	Cross Street: N/A	Location: NE
ADA ID: C1AC7D422D92	Ramp Type: PerpDiag	Initial Pass/Fail: Fail	Overall Compliance: No
		Severity Score: 17.5

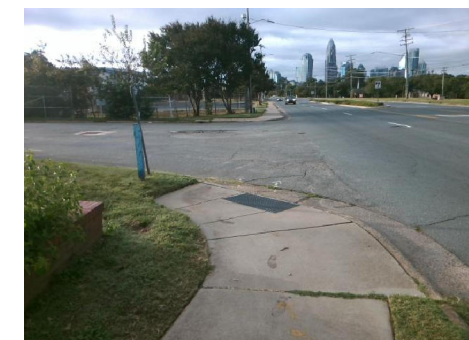
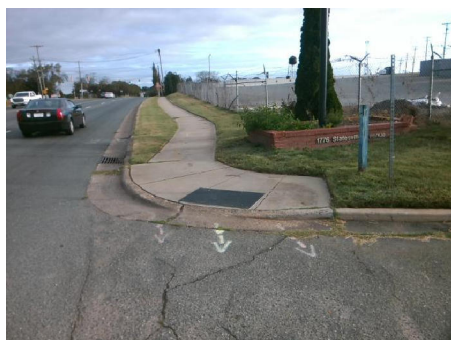
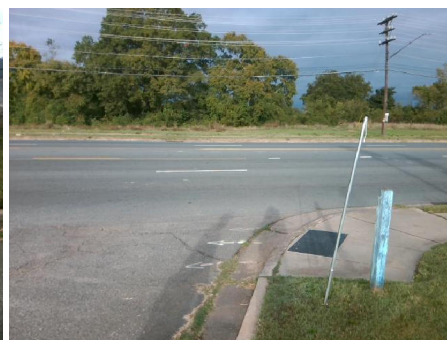
Not Found, R304.5.1

Compliance	Description	Data	Compliance	Description	Data
N/A	Ramp Length (in)	69.0	Yes	Ramp Slope (%)	5.7
No	Ramp Width (in)	32.0	Yes	Ramp XSlope (%)	0.9
N/A	Flare Type LT	N/A	N/A	Flare Type RT	N/A
N/A	Flare Slope LT (%)	N/A	N/A	Flare Slope RT (%)	N/A
N/A	Flare Traversable LT?	N/A	N/A	Flare Traversable RT?	N/A
N/A	Landing Length (in)	N/A	N/A	DWS Provided?	N/A
N/A	Landing Width (in)	N/A	N/A	DWS Contrast?	N/A
N/A	Landing Slope (%)	N/A	N/A	DWS Length (in)	N/A
N/A	Landing X Slope (%)	N/A	N/A	DWS Full Width?	N/A
N/A	Landing Curb? (Y/N)	N/A	N/A	DWS Offset (in)	N/A
N/A	Shared Landing?	N/A			
N/A	Gutter Ponding?	N/A	N/A	Gutter Slope (%)	N/A
N/A	Gutter Lip Ht (in)	N/A	N/A	Gutter X Slope (%)	N/A
N/A	Painted X Walk1?	No	N/A	Painted X Walk2?	No
	X Walk 1 Direction	To W		X Walk 2 Direction	To S
N/A	X Walk 1 Width (in)	N/A	N/A	X Walk 2 Width (in)	N/A
	X Walk 1 Slope (%)	4.0		X Walk 2 Slope (%)	2.0
	X Walk 1 X Slope (%)	1.5		X Walk 2 X Slope (%)	1.3

Remove & Replace Curb Ramp With Two New Directional Ramps or Equivalent.
